Access Compliance Report

Public Rights-of-Way

(Curb Ramps)

| Intersection ID: 10023727 | Main Street: COLISEUM_CENTRE_DR | Cross Street: N/A | Location: W |

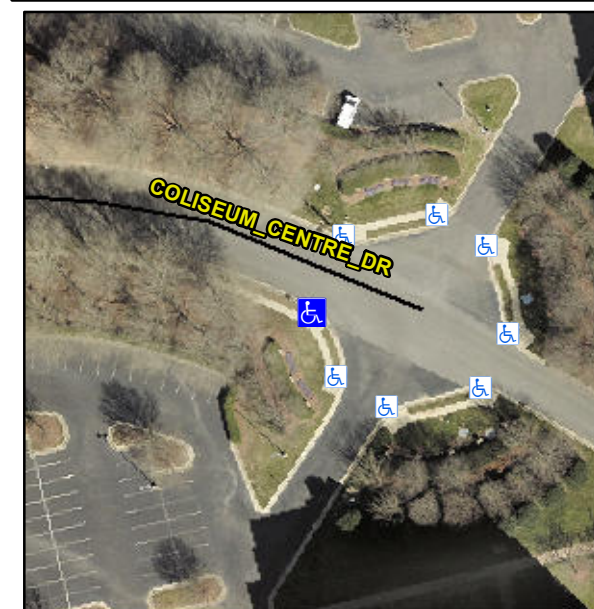
| ADA ID: CC56921A6CF3 | Ramp Type: Perp | Initial Pass/Fail: Fail | Overall Compliance: No |
| Severity Score: 10 | | | |

R304.5.1, R304.5.3

| Compliance | Description | Data | Compliance | Description | Data |
|---|---|---|---|---|---|
| N/A | Ramp Length (in) | 46.5 | Yes | Ramp Slope (%) | 5.8 |
| No | Ramp Width (in) | 44.0 | No | Ramp XSlope (%) | 4.2 |

Possible Solutions:

Remove & Replace Entire Ramp.

Total Cost: \$ 1850.00
