Access Compliance Report

Public Rights-of-Way

(Curb Ramps)

Intersection ID: 11323	Main Street: AIRLIE_ST	Cross Street: SHAMROCK_DR	Location: SE
ADA ID: CC5A74B162E2	Ramp Type: Perp	Initial Pass/Fail: Fail	Overall Compliance: No
Severity Score: 10			
Codes/Mitigation Info/Possible Solution		Field Measurements/Component Compliance

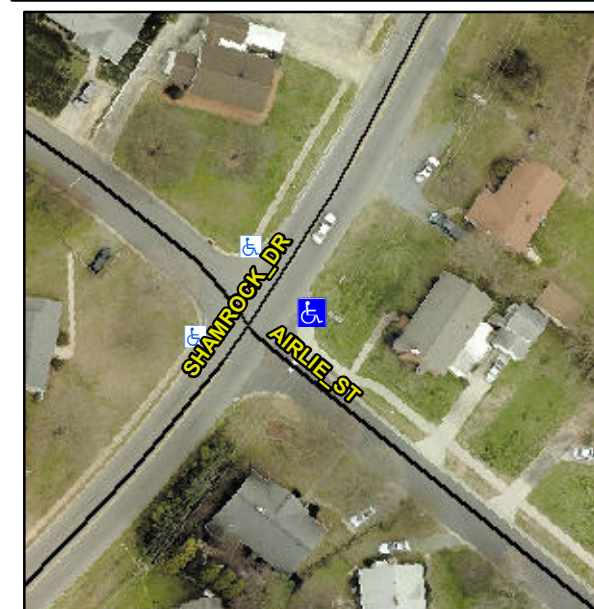
Not Found, R304.5.1, R304.5.3

Compliance	Description	Data	Compliance	Description	Data
N/A	Ramp Length (in)	36.0	Yes	Ramp Slope (%)	5.7
No	Ramp Width (in)	47.0	No	Ramp XSlope (%)	2.3
N/A	Flare Type LT	N/A	N/A	Flare Type RT	N/A
N/A	Flare Slope LT (%)	N/A	N/A	Flare Slope RT (%)	N/A
N/A	Flare Traversable LT?	N/A	N/A	Flare Traversable RT?	N/A
N/A	Landing Length (in)	N/A	N/A	DWS Provided?	N/A
N/A	Landing Width (in)	N/A	N/A	DWS Contrast?	N/A
N/A	Landing Slope (%)	N/A	N/A	DWS Length (in)	N/A
N/A	Landing X Slope (%)	N/A	N/A	DWS Full Width?	N/A
N/A	Landing Curb? (Y/N)	N/A	N/A	DWS Offset (in)	N/A
N/A	Shared Landing?	N/A			
N/A	Gutter Ponding?	N/A	N/A	Gutter Slope (%)	N/A
N/A	Gutter Lip Ht (in)	N/A	N/A	Gutter X Slope (%)	N/A
N/A	Painted X Walk1?	No	N/A	Painted X Walk2?	N/A
	X Walk 1 Direction	To NW		X Walk 2 Direction	N/A
N/A	X Walk 1 Width (in)	N/A	N/A	X Walk 2 Width (in)	N/A
	X Walk 1 Slope (%)	0.6		X Walk 2 Slope (%)	N/A
	X Walk 1 X Slope (%)	1.3		X Walk 2 X Slope (%)	N/A

N/A	Ramp inside XWalk1?	N/A	N/A	Ramp inside XWalk2?	N/A
	Road Slope (%)	N/A	N/A	Clear Space?	N/A
	Road X Slope (%)	N/A	N/A	Clear Space to XWalk (in)	N/A
N/A	Any Obstructions?	N/A	N/A	Storm Grate/Utility Hazard?	N/A
	Obstruction Type			Storm Grate/Utility Type	
		N/A			N/A
			Yes	Surface Condition? (G/P)	Good

Possible Solutions:

Remove & Replace Entire Ramp.
