Access Compliance Report

Public Rights-of-Way

(Curb Ramps)

Intersection ID: 32316	Main Street: NEW_PROVIDENCE_LN	Cross Street: WOODCLIFF_CT	Location: N
ADA ID: CC6E6358F4E3	Ramp Type: Perp	Initial Pass/Fail: Fail	Overall Compliance: No
Severity Score: 33.75			
Codes/Mitigation Info/Possible Solution		Field Measurements/Component Compliance

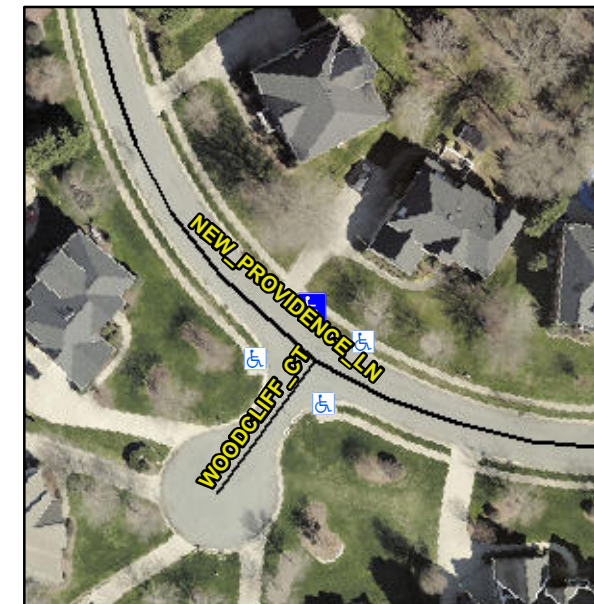
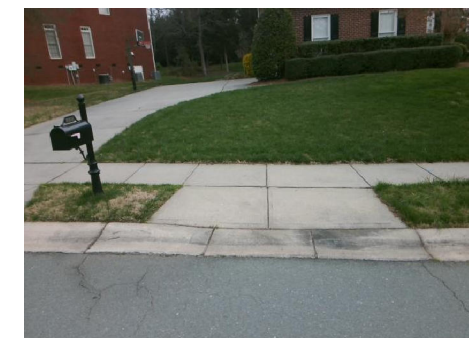
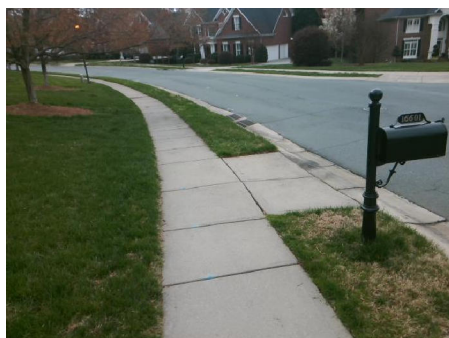
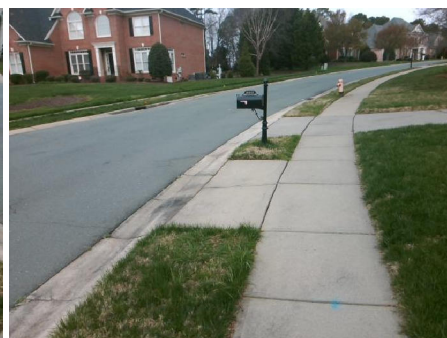
Not Found, R304.5.1, R304.2.2, R304.5.3

Compliance	Description	Data	Compliance	Description	Data
N/A	Ramp Length (in)	47.5	No	Ramp Slope (%)	9.7
No	Ramp Width (in)	45.0	No	Ramp XSlope (%)	5.8
N/A	Flare Type LT	N/A	N/A	Flare Type RT	N/A
N/A	Flare Slope LT (%)	N/A	N/A	Flare Slope RT (%)	N/A
N/A	Flare Traversable LT?	N/A	N/A	Flare Traversable RT?	N/A
N/A	Landing Length (in)	N/A	N/A	DWS Provided?	N/A
N/A	Landing Width (in)	N/A	N/A	DWS Contrast?	N/A
N/A	Landing Slope (%)	N/A	N/A	DWS Length (in)	N/A
N/A	Landing X Slope (%)	N/A	N/A	DWS Full Width?	N/A
N/A	Landing Curb? (Y/N)	N/A	N/A	DWS Offset (in)	N/A
N/A	Shared Landing?	N/A			
N/A	Gutter Ponding?	N/A	N/A	Gutter Slope (%)	N/A
N/A	Gutter Lip Ht (in)	N/A	N/A	Gutter X Slope (%)	N/A
N/A	Painted X Walk1?	No	N/A	Painted X Walk2?	N/A
	X Walk 1 Direction	To SW		X Walk 2 Direction	N/A
N/A	X Walk 1 Width (in)	N/A	N/A	X Walk 2 Width (in)	N/A
	X Walk 1 Slope (%)	3.1		X Walk 2 Slope (%)	N/A
	X Walk 1 X Slope (%)	3.4		X Walk 2 X Slope (%)	N/A

N/A	Ramp inside XWalk1?	N/A	N/A	Ramp inside XWalk2?	N/A
	Road Slope (%)	N/A	N/A	Clear Space?	N/A
	Road X Slope (%)	N/A	N/A	Clear Space to XWalk (in)	N/A
N/A	Any Obstructions?	N/A	N/A	Storm Grate/Utility Hazard?	N/A
	Obstruction Type			Storm Grate/Utility Type	
		N/A			N/A
			Yes	Surface Condition? (G/P)	Good

Remove & Replace Entire Ramp.

Total Cost: \$ 1850.00
