## Access Compliance Report Public Rights-of-Way (Curb Ramps)

/	
Intersection ID: 10037358 Main Street: SAVANNAH_HILLS_DR			Cross Street: DONNELAITH_LN					Location:	w	
ADA ID: CC70C3BB2AC	C3BB2ACE Ramp Type: PerpDiag		Initial P	Initial Pass/Fail: Fail Overall Compliance: N			nce: N	o Severity Score:	25	
Codes/Mitigation Info/Possible Solution					Field Measurements/Component Compliance					
		Possible Solutions:		Compliance Description			Data Compliance Description			
		Remove & Replace Curb Ramp W	Vith	N/A	Ramp Length (in)	97.0	No	Ramp Slope (%)	8.4	
		Two New Directional Ramps or Equivalent.		Yes	Ramp Width (in)	48.0	No	Ramp XSlope (%)	5.5	
				N/A	Flare Type LT	N/A	N/A	Flare Type RT	N/A	
The states as				N/A	Flare Slope LT (%)	N/A	N/A	Flare Slope RT (%)	N/A	
	V MARIA			N/A	Flare Traversable LT?	N/A	N/A	Flare Traversable RT?	N/A	
See I among the second	A CALL			N/A	Landing Length (in)	N/A	N/A	DWS Provided?	N/A	
in the second of the	1000	Surveyor Notes:		N/A	Landing Width (in)	N/A	N/A	DWS Contrast?	N/A

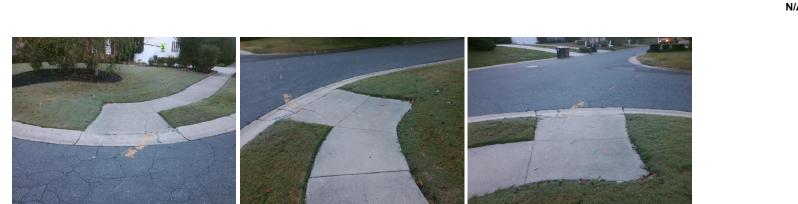
104	1 1 3	N/A		N/A	Landing Slope (%)	N/A	N/A	DWS Length (in)	N/A	
CALL ON CONTRACT				N/A	Landing X Slope (%)	N/A	N/A	DWS Full Width?	N/A	
the second			N/A	Landing Curb? (Y/N)	N/A	N/A	DWS Offset (in)	N/A		
V V				N/A	Shared Landing?	N/A				
	Ser FIL	PROW/ADA:		N/A	Gutter Ponding?	N/A	N/A	Gutter Slope (%)	N/A	
		R304.2.2, R304.5.3		N/A	Gutter Lip Ht (in)	N/A	N/A	Gutter X Slope (%)	N/A	
	Par Miles			N/A	Painted X Walk1?	No	N/A	Painted X Walk2?	No	
					X Walk 1 Direction	To S		X Walk 2 Direction	To E	
A STAR DING	A MARINE			N/A	X Walk 1 Width (in)	N/A	N/A	X Walk 2 Width (in)	N/A	
Street 1 Name	DONNELAITH LN	-			X Walk 1 Slope (%)	2.6		X Walk 2 Slope (%)	7.0	
Stop Condition-Street 2	StopSign				X Walk 1 X Slope (%)	4.0		X Walk 2 X Slope (%)	2.1	
Street 2 Name	SAVANNAH HILLS DR			N/A	Ramp inside XWalk1?	N/A	N/A	Ramp inside XWalk2?	N/A	
Stop Condition-Street 1	None				Road Slope (%)	3.1	N/A	Clear Space?	N/A

Road X Slope (%)	3.5	N/A	Clear Space to XWalk (in)	N/A	
				N/A	Any Obstructions?	N/A	N/A	Storm Grate/Utility Hazard?	N/A	
		Total Cost: \$ 32	200.00		Obstruction Type			Storm Grate/Utility Type		
					••	N/A			N/A
