Access Compliance Report

Public Rights-of-Way

(Curb Ramps)

Intersection ID: 45242	Main Street: TALUS_TRACE_LN	Cross Street: KODIAK_CT	Location: NW
ADA ID: CC85E344B312	Ramp Type: PerpDiag	Initial Pass/Fail: Fail	Overall Compliance: No
Severity Score: 8.75			
Codes/Mitigation Info/Possible Solution		Field Measurements/Component Compliance

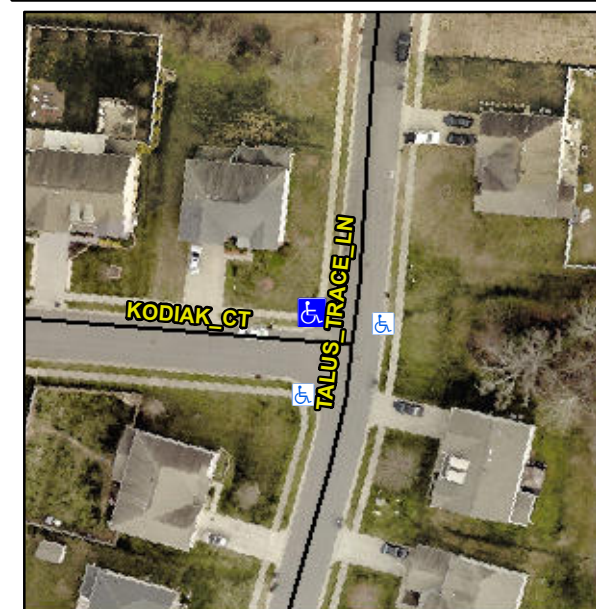
Not Found, R304.5.1

Compliance	Description	Data	Compliance	Description	Data
N/A	Ramp Length (in)	46.5	Yes	Ramp Slope (%)	5.7
No	Ramp Width (in)	47.0	Yes	Ramp XSlope (%)	1.1
N/A	Flare Type LT	N/A	N/A	Flare Type RT	N/A
N/A	Flare Slope LT (%)	N/A	N/A	Flare Slope RT (%)	N/A
N/A	Flare Traversable LT?	N/A	N/A	Flare Traversable RT?	N/A
N/A	Landing Length (in)	N/A	N/A	DWS Provided?	N/A
N/A	Landing Width (in)	N/A	N/A	DWS Contrast?	N/A
N/A	Landing Slope (%)	N/A	N/A	DWS Length (in)	N/A
N/A	Landing X Slope (%)	N/A	N/A	DWS Full Width?	N/A
N/A	Landing Curb? (Y/N)	N/A	N/A	DWS Offset (in)	N/A
N/A	Shared Landing?	N/A			
N/A	Gutter Ponding?	N/A	N/A	Gutter Slope (%)	N/A
N/A	Gutter Lip Ht (in)	0.5	N/A	Gutter X Slope (%)	N/A
N/A	Painted X Walk1?	No	N/A	Painted X Walk2?	No
	X Walk 1 Direction	To S		X Walk 2 Direction	To E
N/A	X Walk 1 Width (in)	N/A	N/A	X Walk 2 Width (in)	N/A
	X Walk 1 Slope (%)	0.5		X Walk 2 Slope (%)	2.0
	X Walk 1 X Slope (%)	0.1		X Walk 2 X Slope (%)	0.7

N/A	Ramp inside XWalk1?	N/A	N/A	Ramp inside XWalk2?	N/A
	Road Slope (%)	0.5	N/A	Clear Space?	N/A
	Road X Slope (%)	1.0	N/A	Clear Space to XWalk (in)	N/A
N/A	Any Obstructions?	N/A	N/A	Storm Grate/Utility Hazard?	N/A
	Obstruction Type			Storm Grate/Utility Type	
		N/A			N/A
		Yes		Surface Condition? (G/P)	Good

Remove & Replace Curb Ramp With Two New Directional Ramps or Equivalent.
