# Access Compliance Report

## Public Rights-of-Way

### (Curb Ramps)

Intersection ID: 43998	Main Street: GANDER_DR	Cross Street: SUMMERBERRY_CT	Location: SE
ADA ID: CC882984BD26	Ramp Type: Perp	Initial Pass/Fail: Fail	Overall Compliance: No
		Severity Score: 10

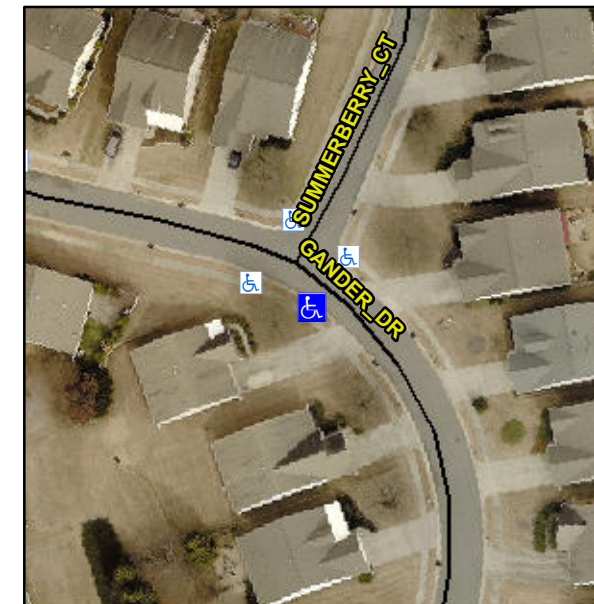
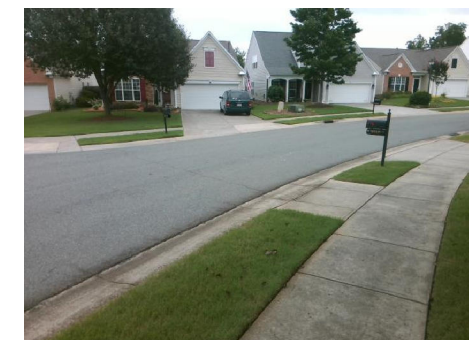
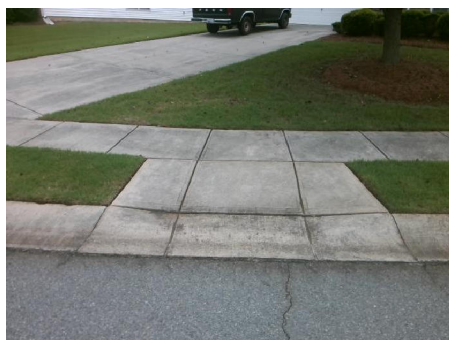
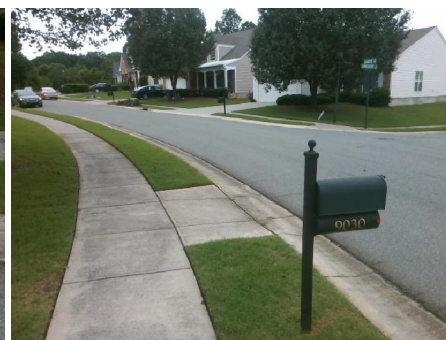
**Not Found, R304.5.1, R304.5.3**

Compliance	Description	Data	Compliance	Description	Data
N/A	Ramp Length (in)	46.0	Yes	Ramp Slope (%)	6.8
No	Ramp Width (in)	46.0	No	Ramp XSlope (%)	4.2
N/A	Flare Type LT	N/A	N/A	Flare Type RT	N/A
N/A	Flare Slope LT (%)	N/A	N/A	Flare Slope RT (%)	N/A
N/A	Flare Traversable LT?	N/A	N/A	Flare Traversable RT?	N/A
N/A	Landing Length (in)	N/A	N/A	DWS Provided?	N/A
N/A	Landing Width (in)	N/A	N/A	DWS Contrast?	N/A
N/A	Landing Slope (%)	N/A	N/A	DWS Length (in)	N/A
N/A	Landing X Slope (%)	N/A	N/A	DWS Full Width?	N/A
N/A	Landing Curb? (Y/N)	N/A	N/A	DWS Offset (in)	N/A
N/A	Shared Landing?	N/A			
N/A	Gutter Ponding?	N/A	N/A	Gutter Slope (%)	N/A
N/A	Gutter Lip Ht (in)	N/A	N/A	Gutter X Slope (%)	N/A
N/A	Painted X Walk1?	No	N/A	Painted X Walk2?	N/A
	X Walk 1 Direction	To NE		X Walk 2 Direction	N/A
N/A	X Walk 1 Width (in)	N/A	N/A	X Walk 2 Width (in)	N/A
	X Walk 1 Slope (%)	4.7		X Walk 2 Slope (%)	N/A
	X Walk 1 X Slope (%)	2.2		X Walk 2 X Slope (%)	N/A

N/A	Ramp inside XWalk1?	N/A	N/A	Ramp inside XWalk2?	N/A
	Road Slope (%)	N/A	N/A	Clear Space?	N/A
	Road X Slope (%)	N/A	N/A	Clear Space to XWalk (in)	N/A
N/A	Any Obstructions?	N/A	N/A	Storm Grate/Utility Hazard?	N/A
	Obstruction Type			Storm Grate/Utility Type	
		N/A			N/A
			Yes	Surface Condition? (G/P)	Good

**Remove & Replace Entire Ramp.**

Total Cost: \$ 1850.00
