Access Compliance Report

Public Rights-of-Way

(Curb Ramps)

Intersection ID: 22250	Main Street: SHARON_LAKES_RD	Cross Street: SOUTH_BV	Location: SW
ADA ID: CC8E87DEE005	Ramp Type: Perp	Initial Pass/Fail: Fail	Overall Compliance: No
Severity Score: 46.25			
Codes/Mitigation Info/Possible Solution		Field Measurements/Component Compliance

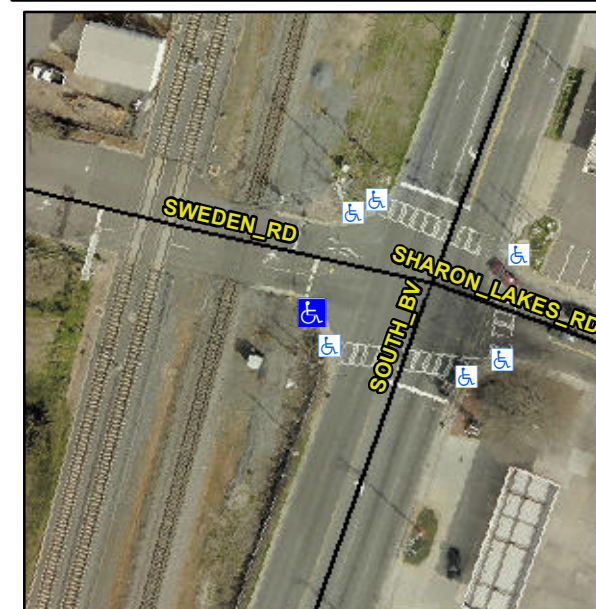
Not Found, R304.5.1, R304.2.2, R304.5.3

Compliance	Description	Data	Compliance	Description	Data
N/A	Ramp Length (in)	48.0	No	Ramp Slope (%)	12.6
No	Ramp Width (in)	39.0	No	Ramp XSlope (%)	6.7
N/A	Flare Type LT	N/A	N/A	Flare Type RT	N/A
N/A	Flare Slope LT (%)	N/A	N/A	Flare Slope RT (%)	N/A
N/A	Flare Traversable LT?	N/A	N/A	Flare Traversable RT?	N/A
N/A	Landing Length (in)	N/A	N/A	DWS Provided?	N/A
N/A	Landing Width (in)	N/A	N/A	DWS Contrast?	N/A
N/A	Landing Slope (%)	N/A	N/A	DWS Length (in)	N/A
N/A	Landing X Slope (%)	N/A	N/A	DWS Full Width?	N/A
N/A	Landing Curb? (Y/N)	N/A	N/A	DWS Offset (in)	N/A
N/A	Shared Landing?	N/A			
N/A	Gutter Ponding?	N/A	N/A	Gutter Slope (%)	N/A
N/A	Gutter Lip Ht (in)	N/A	N/A	Gutter X Slope (%)	N/A
N/A	Painted X Walk1?	No	N/A	Painted X Walk2?	N/A
	X Walk 1 Direction	To NE		X Walk 2 Direction	N/A
N/A	X Walk 1 Width (in)	N/A	N/A	X Walk 2 Width (in)	N/A
	X Walk 1 Slope (%)	2.5		X Walk 2 Slope (%)	N/A
	X Walk 1 X Slope (%)	7.7		X Walk 2 X Slope (%)	N/A

Possible Solutions:

Remove & Replace Entire Ramp.
