# Access Compliance Report

## Public Rights-of-Way

### (Curb Ramps)

Intersection ID: 51369	Main Street: UNIVERSITY_CITY_BV	Cross Street: IKEA_BV	Location: NE
ADA ID: CC90BBB851C2	Ramp Type: Perp	Initial Pass/Fail: Fail	Overall Compliance: No
Severity Score: 37.5			
Codes/Mitigation Info/Possible Solution		Field Measurements/Component Compliance

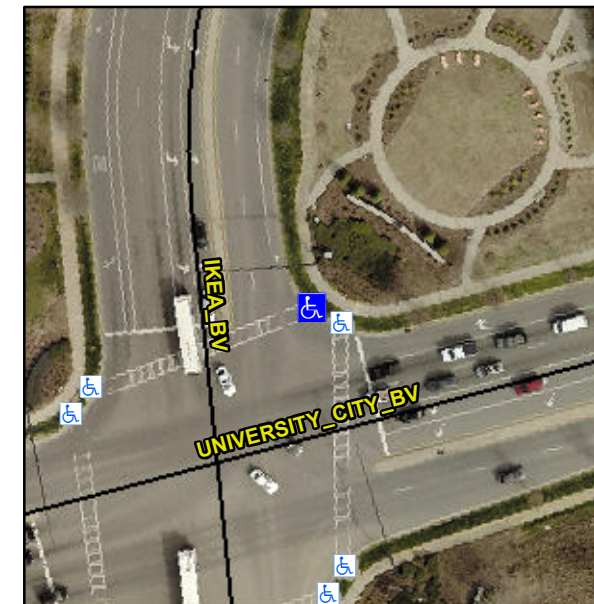
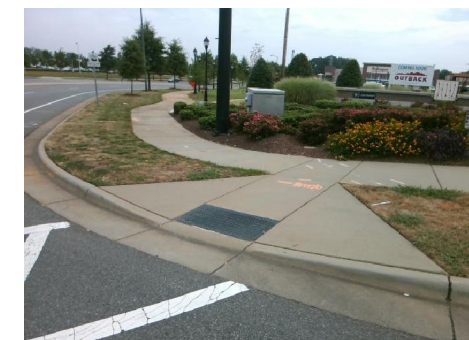
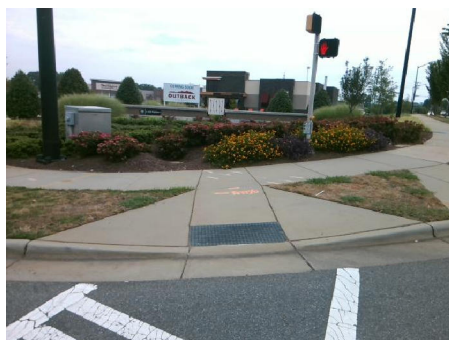
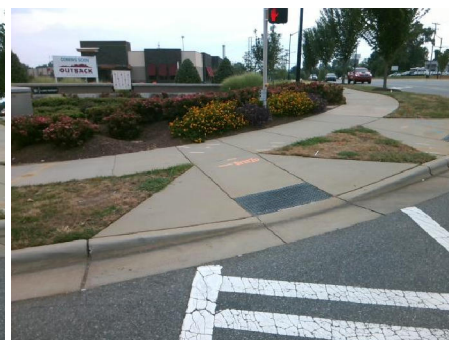
**Not Found, R304.2.2, R304.5.3**

Compliance	Description	Data	Compliance	Description	Data
N/A	Ramp Length (in)	95.0	No	Ramp Slope (%)	8.4
Yes	Ramp Width (in)	48.0	No	Ramp XSlope (%)	7.7
N/A	Flare Type LT	N/A	N/A	Flare Type RT	N/A
N/A	Flare Slope LT (%)	N/A	N/A	Flare Slope RT (%)	N/A
N/A	Flare Traversable LT?	N/A	N/A	Flare Traversable RT?	N/A
N/A	Landing Length (in)	N/A	N/A	DWS Provided?	N/A
N/A	Landing Width (in)	N/A	N/A	DWS Contrast?	N/A
N/A	Landing Slope (%)	N/A	N/A	DWS Length (in)	N/A
N/A	Landing X Slope (%)	N/A	N/A	DWS Full Width?	N/A
N/A	Landing Curb? (Y/N)	N/A	N/A	DWS Offset (in)	N/A
N/A	Shared Landing?	N/A			
N/A	Gutter Ponding?	N/A	N/A	Gutter Slope (%)	N/A
N/A	Gutter Lip Ht (in)	1.0	N/A	Gutter X Slope (%)	N/A
N/A	Painted X Walk1?	Yes	N/A	Painted X Walk2?	N/A
	X Walk 1 Direction	To W		X Walk 2 Direction	N/A
N/A	X Walk 1 Width (in)	80.0	N/A	X Walk 2 Width (in)	N/A
	X Walk 1 Slope (%)	2.9		X Walk 2 Slope (%)	N/A
	X Walk 1 X Slope (%)	5.5		X Walk 2 X Slope (%)	N/A

N/A	Ramp inside XWalk1?	Yes	N/A	Ramp inside XWalk2?	N/A
	Road Slope (%)	N/A	N/A	Clear Space?	N/A
	Road X Slope (%)	N/A	N/A	Clear Space to XWalk (in)	N/A
N/A	Any Obstructions?	N/A	N/A	Storm Grate/Utility Hazard?	N/A
	Obstruction Type			Storm Grate/Utility Type	
		N/A			N/A
		Yes		Surface Condition? (G/P)	Good

**Remove & Replace Entire Ramp.**
