Access Compliance Report Public Rights-of-Way (Curb Ramps)

Intersection ID: 10038195Main Street:SKYLAND_AVCross Street: N/ANEADA ID: CC97C93CFE7BRamp Type:ParaInitial Pass/Fail:FailOverall Compliance: NoSeverity Score:12.5

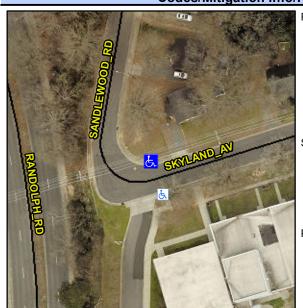
Field Measurements/Component Compliance							
Comp	liance Description	Data	Comp	oliance Description	Data			
N/A	Ramp Length LT (in)	57.5	N/A	Ramp Length RT (in)	71.0			
Yes	Ramp Width LT (in)	62.0	Yes	Ramp Width RT (in)	62.0			
Yes	Ramp Slope LT (%)	7.9	No	Ramp Slope RT (%)	10.8			
Yes	Ramp XSlope LT (%)	0.7	Yes	Ramp XSlope RT (%)	1.0			
N/A	Landing Length (in)	N/A	N/A	DWS Provided?	N/A			
N/A	Landing Width (in)	N/A	N/A	DWS Contrast?	N/A			
N/A	Landing Slope (%)	N/A	N/A	DWS Length (in)	N/A			
N/A	Landing X Slope (%)	N/A	N/A	DWS Full Width?	N/A			
N/A	Landing Curb? (Y/N)	N/A	N/A	DWS Offset (in)	N/A			
N/A	Shared Landing?	N/A						
N/A	Gutter Ponding?	N/A	N/A	Gutter Slope (%)	N/A			
N/A	Gutter Lip Ht (in)	N/A	N/A	Gutter X Slope (%)	N/A			
N/A	Painted X Walk1?	No	N/A	Painted X Walk2?	N/A			
	X Walk 1 Direction	To SE		X Walk 2 Direction	N/A			
N/A	X Walk 1 Width (in)	N/A	N/A	X Walk 2 Width (in)	N/A			
	X Walk 1 Slope (%)	4.7		X Walk 2 Slope (%)	N/A

X Walk 1 X Slope (%)	1.9		X Walk 2 X Slope (%)	N/A			
N/A	Ramp inside XWalk1?	N/A	N/A	Ramp inside XWalk2?	N/A			
	Road Slope (%)	N/A	N/A	Clear Space?	N/A			
	Road X Slope (%)	N/A	N/A	Clear Space to XWalk (in)	N/A			
N/A	Any Obstructions?	N/A	N/A	Storm Grate/Utility Hazard?	N/A			
	Obstruction Type			Storm Grate/Utility Type				
		N/A			N/A			
			Yes	Surface Condition? (G/P)	Good			
			N/A	Curb Slope (%)	7.6			
/ Wap L		•	•	, , ,

COCIDIO COIGNION	
Possible Solutions:	Cor
Remove & Replace Entire Ramp.	N/A
·	Yes
	Yes
	Yes
	N/A
	N/A
Surveyor Notes:	N/A
N/A	N/A
	N/A
	N/A
	N/A
PROW/ADA:	N/A
R304.3.2	N/A
	N/A
	N/A

Total Cost:	\$ 1600.00
