Access Compliance Report

Public Rights-of-Way

(Curb Ramps)

Intersection ID: 53886	Main Street: PAW_VALLEY_LN	Cross Street: PAW_VILLAGE_RD	Location:	N
ADA ID: CC99110F35A6	Ramp Type: BlendTrans1	Initial Pass/Fail: Fail	Overall Compliance: No	Severity Score: 10

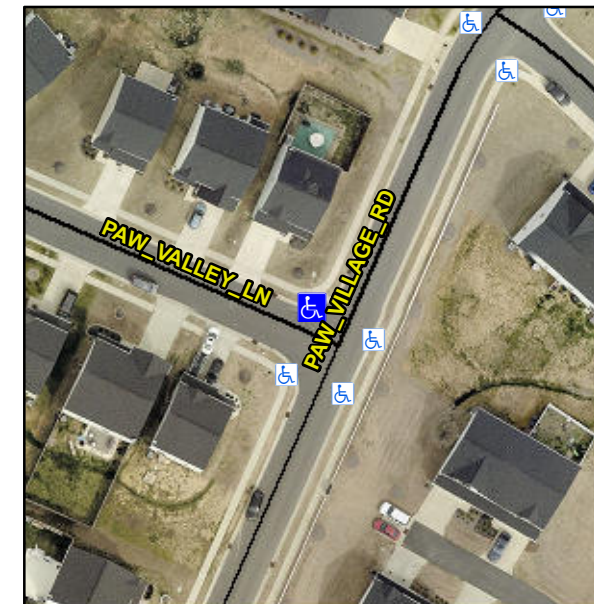
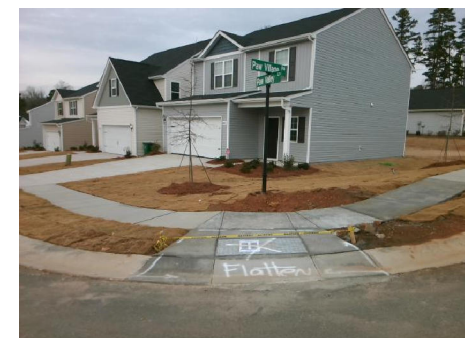
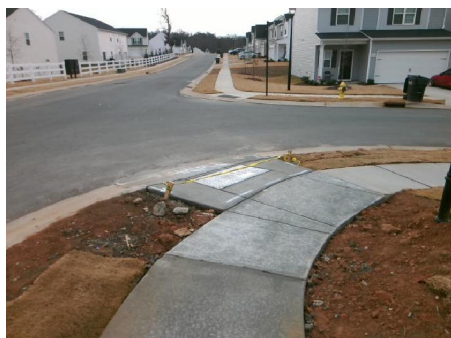
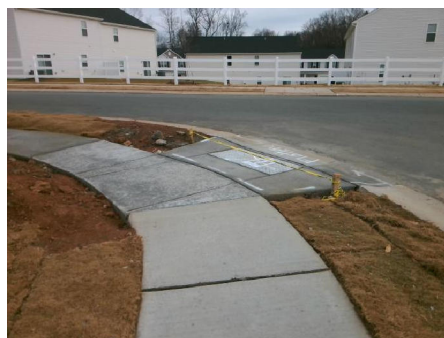
Not Found, R304.5.1, R304.5.3

Compliance	Description	Data	Compliance	Description	Data
N/A	Ramp Length (in)	48.0	Yes	BlendTrans Slope (%)	2.7
No	Ramp Width (in)	47.5	No	BlendTrans XSlope (%)	4.1
N/A	Flare Type LT	N/A	N/A	Flare Type RT	N/A
N/A	Flare Slope LT (%)	N/A	N/A	Flare Slope RT (%)	N/A
N/A	Flare Traversable LT?	N/A	N/A	Flare Traversable RT?	N/A
N/A	Landing Length (in)	N/A	N/A	DWS Provided?	N/A
N/A	Landing Width (in)	N/A	N/A	DWS Contrast?	N/A
N/A	Landing Slope (%)	N/A	N/A	DWS Length (in)	N/A
N/A	Landing X Slope (%)	N/A	N/A	DWS Full Width?	N/A
N/A	Landing Curb? (Y/N)	N/A	N/A	DWS Offset (in)	N/A
N/A	Shared Landing?	N/A			
N/A	Gutter Ponding?	N/A	N/A	Gutter Slope (%)	N/A
N/A	Gutter Lip Ht (in)	N/A	N/A	Gutter X Slope (%)	N/A
N/A	Painted X Walk1?	No	N/A	Painted X Walk2?	No
	X Walk 1 Direction	To SW		X Walk 2 Direction	To SE
	X Walk 1 Width (in)	N/A		X Walk 2 Width (in)	N/A
	X Walk 1 Slope (%)	2.8		X Walk 2 Slope (%)	6.7
	X Walk 1 X Slope (%)	7.0		X Walk 2 X Slope (%)	0.6

N/A	Ramp inside XWalk1?	N/A	N/A	Ramp inside XWalk2?	N/A
	Road Slope (%)	3.5		Clear Space?	N/A
	Road X Slope (%)	5.1	N/A	Clear Space to XWalk (in)	N/A
N/A	Any Obstructions?	N/A	N/A	Storm Grate/Utility Hazard?	N/A
	Obstruction Type			Storm Grate/Utility Type	
		N/A			N/A
			Yes	Surface Condition? (G/P)	Good
			No	Curb Slope (%)	7.6

Remove & Replace Curb Ramp With Two New Directional Ramps or Equivalent.
