Access Compliance Report

Public Rights-of-Way

(Curb Ramps)

Intersection ID: 13035	Main Street: W_CARSON_BV	Cross Street: WINNIFRED_ST	Location: NE
ADA ID: CCA140AA4F6D	Ramp Type: Directional1	Initial Pass/Fail: Fail	Overall Compliance: No
Severity Score: 1.25			
Codes/Mitigation Info/Possible Solution		Field Measurements/Component Compliance

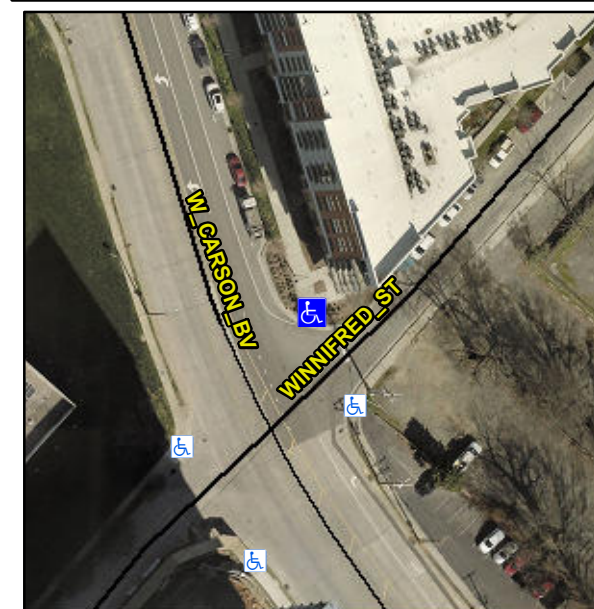
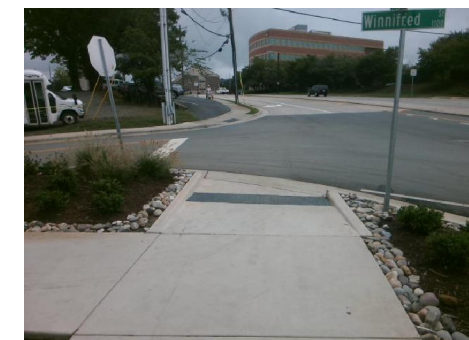
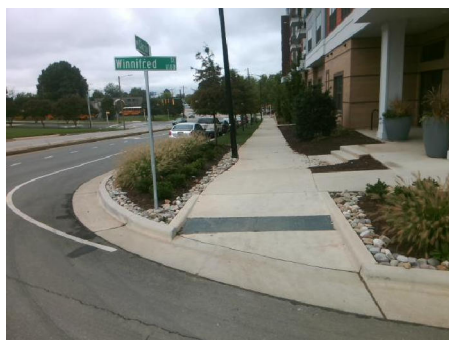
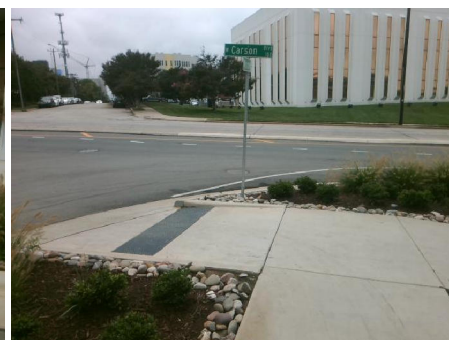
Compliance	Description	Data	Compliance	Description	Data
N/A	Ramp Length (in)	79.0	N/A	Grade Break?	N/A
Yes	Ramp Width (in)	94.0	N/A	Grade Break Slope (%)	0.0
Yes	Ramp Slope (%)	2.5	N/A	Grade Break XSlope (%)	0.0
No	Ramp XSlope (%)	2.1			
N/A	Flare Type LT	N/A	N/A	Flare Type RT	N/A
N/A	Flare Slope LT (%)	N/A	N/A	Flare Slope RT (%)	0.0
N/A	Flare Traversable LT?	N/A	N/A	Flare Traversable RT?	N/A
N/A	Landing Length (in)	0.0	N/A	DWS Provided?	N/A
N/A	Landing Width (in)	0.0	N/A	DWS Contrast?	N/A
N/A	Landing Slope (%)	0.0	N/A	DWS Length (in)	N/A
N/A	Landing X Slope (%)	0.0	N/A	DWS Full Width?	N/A
N/A	Landing Curb? (Y/N)	N/A	N/A	DWS Offset LT (in)	N/A
N/A	Shared Landing?	N/A	N/A	DWS Offset RT (in)	N/A
N/A	Gutter Ponding?	0.0	N/A	Gutter Slope (%)	N/A
N/A	Gutter Lip Ht (in)	0.0	N/A	Gutter X Slope (%)	N/A
N/A	Painted X Walk1?	No		Road Slope (%)	5.8
	X Walk 1 Direction	To SE		Road X Slope (%)	2.1
	X Walk 1 Width (in)	N/A		Clear Space?	N/A

X Walk 1 Slope (%)	5.8	N/A	Clear Space to XWalk (in)	N/A
	X Walk 1 X Slope (%)	2.1	N/A	Storm Grate/Utility Hazard?	N/A
N/A	Ramp inside XWalk1?	N/A		Storm Grate/Utility Type	
N/A	Any Obstructions?	N/A			N/A
	Obstruction Type		Yes	Surface Condition? (G/P)	Good
			N/A	Curb Slope (%)	5.0

Possible Solutions:

Remove & Replace Entire Ramp.

R304.5.3
