Access Compliance Report

Public Rights-of-Way

(Curb Ramps)

Intersection ID: 10034961	Main Street: PROVIDENCE_RD_WEST	Cross Street: N/A	Location: SE
ADA ID: CCA1B5CC83ED	Ramp Type: PerpDiag	Initial Pass/Fail: Fail	Overall Compliance: No
Severity Score: 12.5			
Codes/Mitigation Info/Possible Solution		Field Measurements/Component Compliance

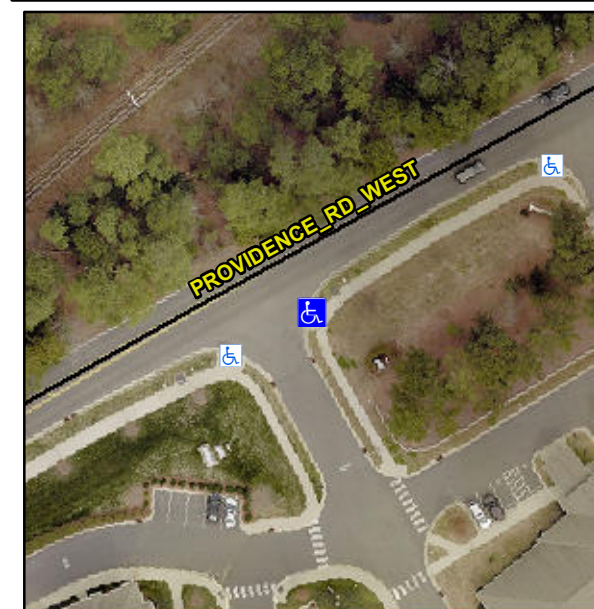
Compliance	Description	Data	Compliance	Description	Data
N/A	Ramp Length (in)	58.0	No	Ramp Slope (%)	11.1
Yes	Ramp Width (in)	48.0	Yes	Ramp XSlope (%)	1.3
N/A	Flare Type LT	N/A	N/A	Flare Type RT	N/A
N/A	Flare Slope LT (%)	N/A	N/A	Flare Slope RT (%)	N/A
N/A	Flare Traversable LT?	N/A	N/A	Flare Traversable RT?	N/A
N/A	Landing Length (in)	N/A	N/A	DWS Provided?	N/A
N/A	Landing Width (in)	N/A	N/A	DWS Contrast?	N/A
N/A	Landing Slope (%)	N/A	N/A	DWS Length (in)	N/A
N/A	Landing X Slope (%)	N/A	N/A	DWS Full Width?	N/A
N/A	Landing Curb? (Y/N)	N/A	N/A	DWS Offset (in)	N/A
N/A	Shared Landing?	N/A			
N/A	Gutter Ponding?	N/A	N/A	Gutter Slope (%)	N/A
N/A	Gutter Lip Ht (in)	N/A	N/A	Gutter X Slope (%)	N/A
N/A	Painted X Walk1?	No	N/A	Painted X Walk2?	No
	X Walk 1 Direction	To N		X Walk 2 Direction	To SW
N/A	X Walk 1 Width (in)	N/A	N/A	X Walk 2 Width (in)	N/A
	X Walk 1 Slope (%)	3.3		X Walk 2 Slope (%)	1.9
	X Walk 1 X Slope (%)	0.9		X Walk 2 X Slope (%)	0.6

N/A	Ramp inside XWalk1?	N/A	N/A	Ramp inside XWalk2?	N/A
	Road Slope (%)	2.3	N/A	Clear Space?	N/A
	Road X Slope (%)	1.5	N/A	Clear Space to XWalk (in)	N/A
N/A	Any Obstructions?	N/A	N/A	Storm Grate/Utility Hazard?	N/A
	Obstruction Type			Storm Grate/Utility Type	
		N/A			N/A
			Yes	Surface Condition? (G/P)	Good

Remove & Replace Curb Ramp With Two New Directional Ramps or Equivalent.

R304.2.2
