Access Compliance Report

Public Rights-of-Way

(Curb Ramps)

Intersection ID: 42772	Main Street: JEANETTE_CR	Cross Street: SWANSONG_LN	Location: W
ADA ID: CCA7F79362E6	Ramp Type: PerpDiag	Initial Pass/Fail: Fail	Overall Compliance: No
Severity Score: 17.5			
Codes/Mitigation Info/Possible Solution		Field Measurements/Component Compliance

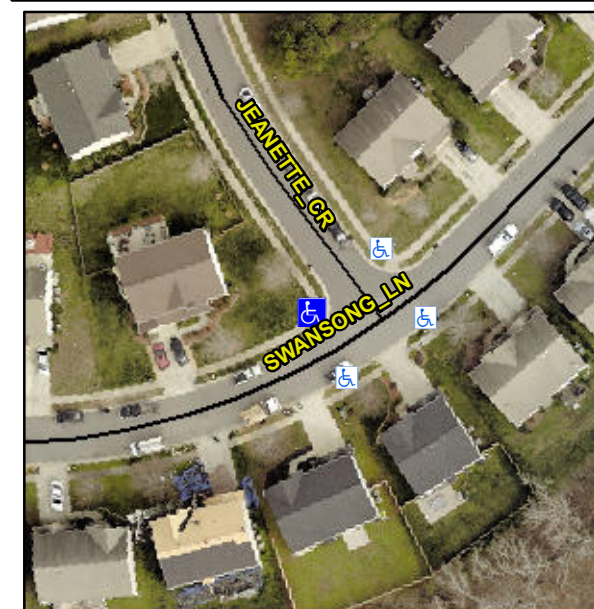
Not Found, R304.5.1

Compliance	Description	Data	Compliance	Description	Data
N/A	Ramp Length (in)	46.5	Yes	Ramp Slope (%)	6.2
No	Ramp Width (in)	35.0	Yes	Ramp XSlope (%)	0.4
N/A	Flare Type LT	N/A	N/A	Flare Type RT	N/A
N/A	Flare Slope LT (%)	N/A	N/A	Flare Slope RT (%)	N/A
N/A	Flare Traversable LT?	N/A	N/A	Flare Traversable RT?	N/A
N/A	Landing Length (in)	N/A	N/A	DWS Provided?	N/A
N/A	Landing Width (in)	N/A	N/A	DWS Contrast?	N/A
N/A	Landing Slope (%)	N/A	N/A	DWS Length (in)	N/A
N/A	Landing X Slope (%)	N/A	N/A	DWS Full Width?	N/A
N/A	Landing Curb? (Y/N)	N/A	N/A	DWS Offset (in)	N/A
N/A	Shared Landing?	N/A			
N/A	Gutter Ponding?	N/A	N/A	Gutter Slope (%)	N/A
N/A	Gutter Lip Ht (in)	N/A	N/A	Gutter X Slope (%)	N/A
N/A	Painted X Walk1?	No	N/A	Painted X Walk2?	No
	X Walk 1 Direction	To E		X Walk 2 Direction	To S
N/A	X Walk 1 Width (in)	N/A	N/A	X Walk 2 Width (in)	N/A
	X Walk 1 Slope (%)	1.7		X Walk 2 Slope (%)	0.1
	X Walk 1 X Slope (%)	1.6		X Walk 2 X Slope (%)	0.1

Remove & Replace Curb Ramp With Two New Directional Ramps or Equivalent.

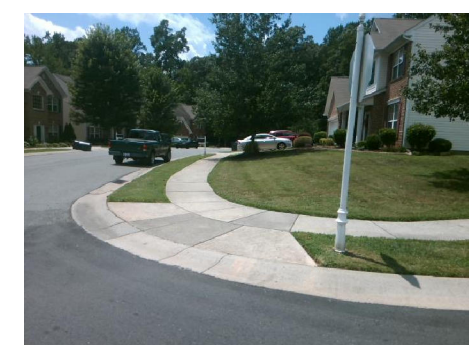
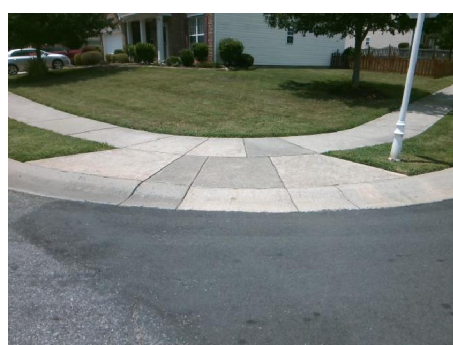
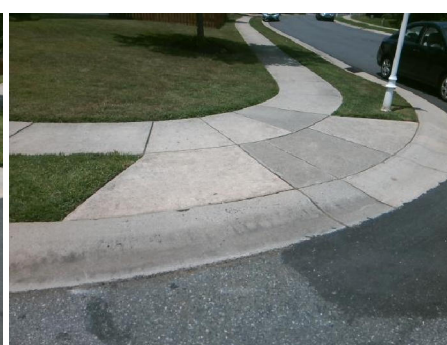
N/A	Ramp inside XWalk1?	N/A	N/A	Ramp inside XWalk2?	N/A
	Road Slope (%)	0.0	N/A	Clear Space?	N/A
	Road X Slope (%)	1.1	N/A	Clear Space to XWalk (in)	N/A
N/A	Any Obstructions?	N/A	N/A	Storm Grate/Utility Hazard?	N/A
	Obstruction Type			Storm Grate/Utility Type	
		N/A			N/A
		Yes		Surface Condition? (G/P)	Good
