Access Compliance Report

Public Rights-of-Way

(Curb Ramps)

Intersection ID: N/A	Main Street: AGNEW_DR	Cross Street: VAWTER_RD	Location: SE
ADA ID: CCAF64BDADE5	Ramp Type: BlendTrans1	Initial Pass/Fail: Fail	Overall Compliance: No
		Severity Score: 10

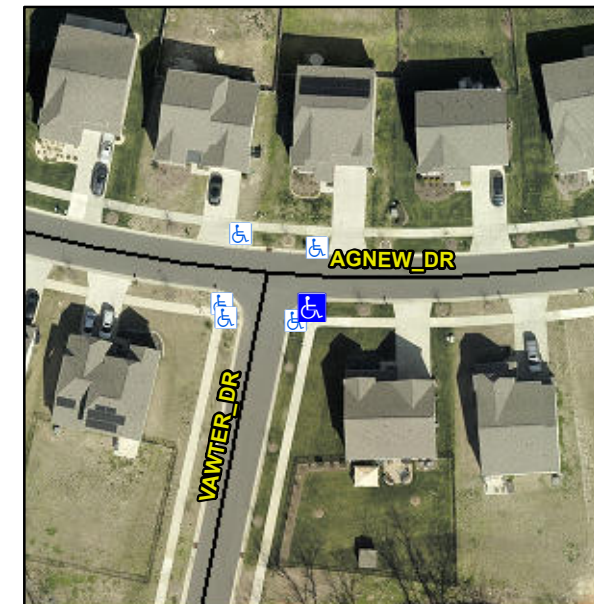
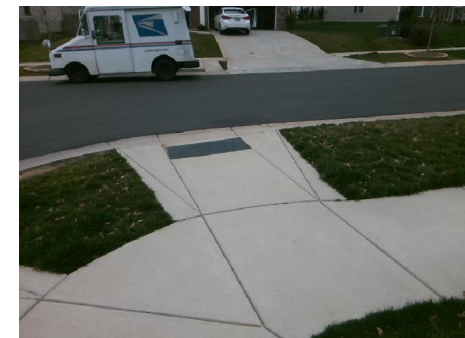
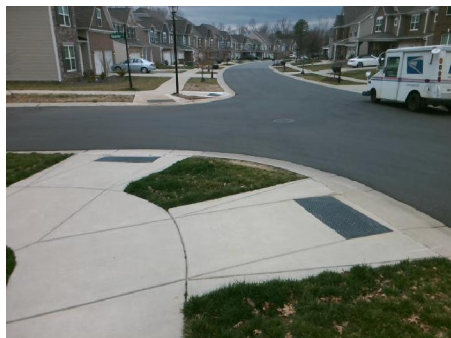
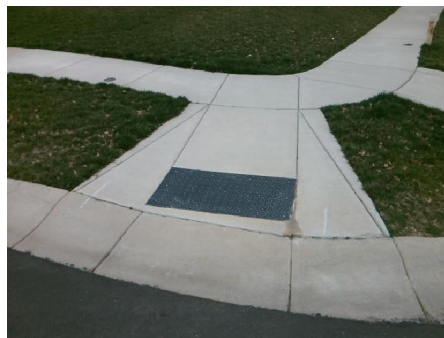
R304.5.1, R304.5.3

Compliance	Description	Data	Compliance	Description	Data
N/A	Ramp Length (in)	95.0	Yes	BlendTrans Slope (%)	1.5
No	Ramp Width (in)	46.5	No	BlendTrans XSlope (%)	3.7
N/A	Flare Type LT	N/A	N/A	Flare Type RT	N/A
N/A	Flare Slope LT (%)	N/A	N/A	Flare Slope RT (%)	N/A
N/A	Flare Traversable LT?	N/A	N/A	Flare Traversable RT?	N/A
N/A	Landing Length (in)	N/A	N/A	DWS Provided?	N/A
N/A	Landing Width (in)	N/A	N/A	DWS Contrast?	N/A
N/A	Landing Slope (%)	N/A	N/A	DWS Length (in)	N/A
N/A	Landing X Slope (%)	N/A	N/A	DWS Full Width?	N/A
N/A	Landing Curb? (Y/N)	N/A	N/A	DWS Offset (in)	N/A
N/A	Shared Landing?	N/A			
N/A	Gutter Ponding?	N/A	N/A	Gutter Slope (%)	N/A
N/A	Gutter Lip Ht (in)	N/A	N/A	Gutter X Slope (%)	N/A
N/A	Painted X Walk1?	No	N/A	Painted X Walk2?	N/A
	X Walk 1 Direction	To N		X Walk 2 Direction	N/A
	X Walk 1 Width (in)	N/A		X Walk 2 Width (in)	N/A
	X Walk 1 Slope (%)	5.6		X Walk 2 Slope (%)	N/A
	X Walk 1 X Slope (%)	3.0		X Walk 2 X Slope (%)	N/A

N/A	Ramp inside XWalk1?	N/A	N/A	Ramp inside XWalk2?	N/A
	Road Slope (%)	3.0		Clear Space?	N/A
	Road X Slope (%)	5.6	N/A	Clear Space to XWalk (in)	N/A
N/A	Any Obstructions?	N/A	N/A	Storm Grate/Utility Hazard?	N/A
	Obstruction Type			Storm Grate/Utility Type	
		N/A			N/A
			Yes	Surface Condition? (G/P)	Good
			N/A	Curb Slope (%)	2.9

Remove & Replace Curb Ramp With Two New Directional Ramps or Equivalent.
