Access Compliance Report Public Rights-of-Way (Curb Ramps)

Main Street: PARK RD Intersection ID: 42705 **Cross Street: SHARON RD** Location: NE **Overall Compliance: No** 25 ADA ID: CCC33AAD3E30 Ramp Type: IslandPerp Initial Pass/Fail: Fail **Severity Score:**

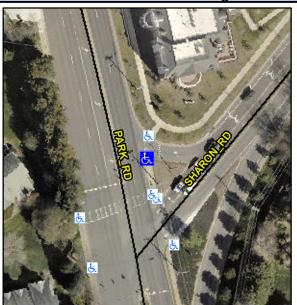
1 0331bic Odiation		i icia ivic
Possible Solutions:	Comp	liance Description
Remove & Replace Entire Ramp.	N/A	Ramp Length (in)
•	Yes	Ramp Width (in)
	N/A	Flare Type LT
	N/A	Flare Slope LT (%)
	N/A	Flare Traversable L1
	N/A	Landing Length (in)
Surveyor Notes:	N/A	Landing Width (in)
N/A	N/A	Landing Slope (%)
	N/A	Landing X Slope (%
	N/A	Landing Curb? (Y/N
	N/A	Shared Landing?
PROW/ADA:	N/A	Gutter Ponding?
R304.2.2, R304.5.3	N/A	Gutter Lip Ht (in)
	N/A	Painted X Walk1?
		X Walk 1 Direction
	N/A	X Walk 1 Width (in)
		X Walk 1 Slope (%)
		X Walk 1 X Slope (%
