Access Compliance Report

Public Rights-of-Way

(Curb Ramps)

Intersection ID: 18055	Main Street: IDLEWILD_RD	Cross Street: LAILWOOD_CR	Location: SE
ADA ID: CCC344C1ED31	Ramp Type: BlendTrans1	Initial Pass/Fail: Fail	Overall Compliance: No
Severity Score: 1.25			
Codes/Mitigation Info/Possible Solution		Field Measurements/Component Compliance

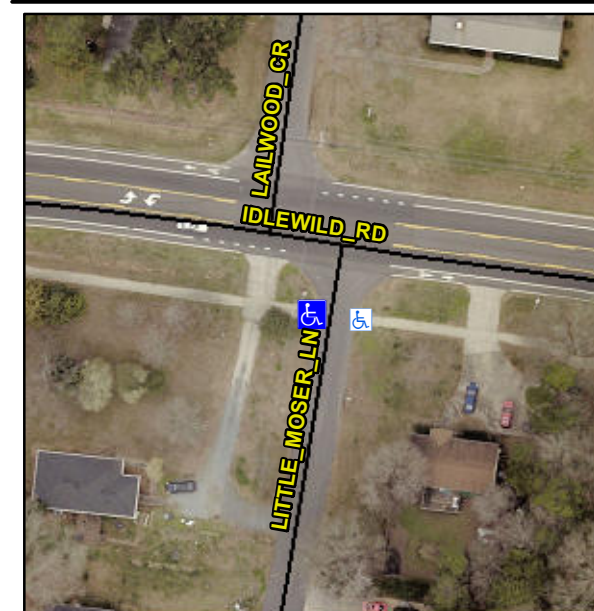
NO CURB LINE

Compliance	Description	Data	Compliance	Description	Data
N/A	Ramp Length (in)	75.0	Yes	BlendTrans Slope (%)	0.8
Yes	Ramp Width (in)	70.0	No	BlendTrans XSlope (%)	2.9
N/A	Flare Type LT	N/A	N/A	Flare Type RT	N/A
N/A	Flare Slope LT (%)	N/A	N/A	Flare Slope RT (%)	N/A
N/A	Flare Traversable LT?	N/A	N/A	Flare Traversable RT?	N/A
N/A	Landing Length (in)	N/A	N/A	DWS Provided?	N/A
N/A	Landing Width (in)	N/A	N/A	DWS Contrast?	N/A
N/A	Landing Slope (%)	N/A	N/A	DWS Length (in)	N/A
N/A	Landing X Slope (%)	N/A	N/A	DWS Full Width?	N/A
N/A	Landing Curb? (Y/N)	N/A	N/A	DWS Offset (in)	N/A
N/A	Shared Landing?	N/A			
N/A	Gutter Ponding?	N/A	N/A	Gutter Slope (%)	N/A
N/A	Gutter Lip Ht (in)	N/A	N/A	Gutter X Slope (%)	N/A
N/A	Painted X Walk1?	No	N/A	Painted X Walk2?	N/A
	X Walk 1 Direction	To E		X Walk 2 Direction	N/A
	X Walk 1 Width (in)	N/A		X Walk 2 Width (in)	N/A
	X Walk 1 Slope (%)	2.2		X Walk 2 Slope (%)	N/A
	X Walk 1 X Slope (%)	7.3		X Walk 2 X Slope (%)	N/A

N/A	Ramp inside XWalk1?	N/A	N/A	Ramp inside XWalk2?	N/A
	Road Slope (%)	7.3		Clear Space?	N/A
	Road X Slope (%)	2.2	N/A	Clear Space to XWalk (in)	N/A
N/A	Any Obstructions?	N/A	N/A	Storm Grate/Utility Hazard?	N/A
	Obstruction Type			Storm Grate/Utility Type	
		N/A			N/A
			Yes	Surface Condition? (G/P)	Good
			N/A	Curb Slope (%)	N/A

Remove & Replace Curb Ramp With Two New Directional Ramps or Equivalent.

R304.5.3
