Access Compliance Report

Public Rights-of-Way

(Curb Ramps)

Intersection ID: 3925	Main Street: OAK_MANOR_LN	Cross Street: WOODFORD_BRIDGE_DR	Location:	N
ADA ID: CCCA57F0016D	Ramp Type: Perp	Initial Pass/Fail: Fail	Overall Compliance: No	Severity Score: 25

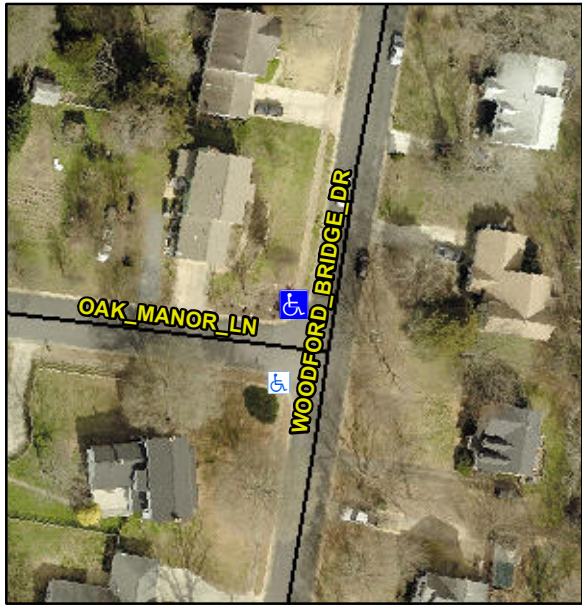
Possible Solutions:		Compliance	Description	Data	Compliance	Description	Data
	Remove & Replace Entire Ramp.		N/A	Ramp Length (in)	30.0	Yes	Ramp Slope (%)	5.0
			Yes	Ramp Width (in)	48.0	No	Ramp XSlope (%)	7.6
			N/A	Flare Type LT	N/A	N/A	Flare Type RT	N/A
			N/A	Flare Slope LT (%)	N/A	N/A	Flare Slope RT (%)	N/A
			N/A	Flare Traversable LT?	N/A	N/A	Flare Traversable RT?	N/A
			N/A	Landing Length (in)	N/A	N/A	DWS Provided?	N/A
			N/A	Landing Width (in)	N/A	N/A	DWS Contrast?	N/A
			N/A	Landing Slope (%)	N/A	N/A	DWS Length (in)	N/A
			N/A	Landing X Slope (%)	N/A	N/A	DWS Full Width?	N/A
Surveyor Notes:			N/A	Landing Curb? (Y/N)	N/A	N/A	DWS Offset (in)	N/A
N/A			N/A	Shared Landing?	N/A			
PROW/ADA:			N/A	Gutter Ponding?	N/A	N/A	Gutter Slope (%)	N/A
Not Found, R304.5.3			N/A	Gutter Lip Ht (in)	N/A	N/A	Gutter X Slope (%)	N/A

N/A	Painted X Walk1?	No	N/A	Painted X Walk2?	N/A
				X Walk 1 Direction	To S		X Walk 2 Direction	N/A
			N/A	X Walk 1 Width (in)	N/A	N/A	X Walk 2 Width (in)	N/A
				X Walk 1 Slope (%)	6.9		X Walk 2 Slope (%)	N/A
				X Walk 1 X Slope (%)	2.0		X Walk 2 X Slope (%)	N/A
			N/A	Ramp inside XWalk1?	N/A	N/A	Ramp inside XWalk2?	N/A
				Road Slope (%)	N/A	N/A	Clear Space?	N/A
				Road X Slope (%)	N/A	N/A	Clear Space to XWalk (in)	N/A
			N/A	Any Obstructions?	N/A	N/A	Storm Grate/Utility Hazard?	N/A
				Obstruction Type			Storm Grate/Utility Type	
						N/A		N/A
						Yes	Surface Condition? (G/P)	Good
Total Cost:		\$ 1850.00
