# Access Compliance Report

## Public Rights-of-Way

### (Curb Ramps)

Intersection ID: 14628	Main Street: ALBEMARLE_RD	Cross Street: ALMOND_RD	Location:	N
ADA ID: CCD886332152	Ramp Type: Perp	Initial Pass/Fail: Fail	Overall Compliance: No	Severity Score: 21.25
Codes/Mitigation Info/Possible Solution		Field Measurements/Component Compliance

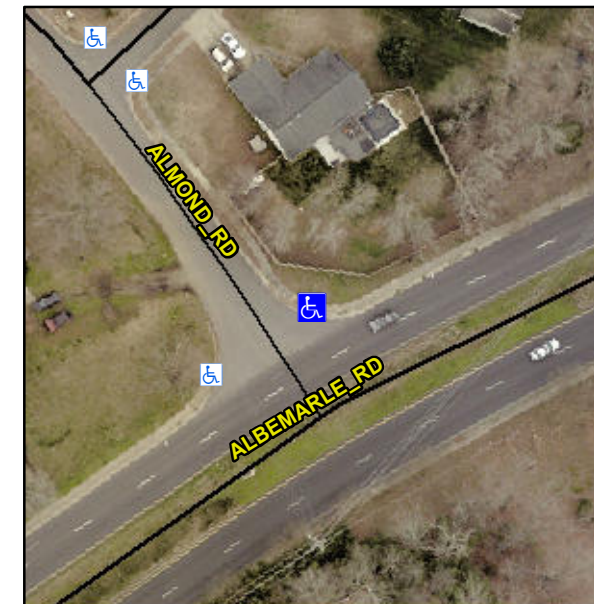
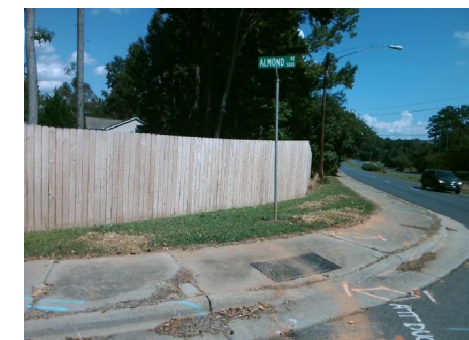
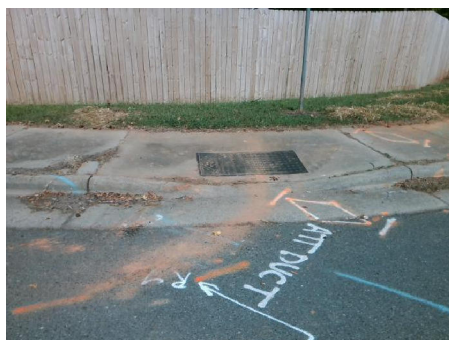
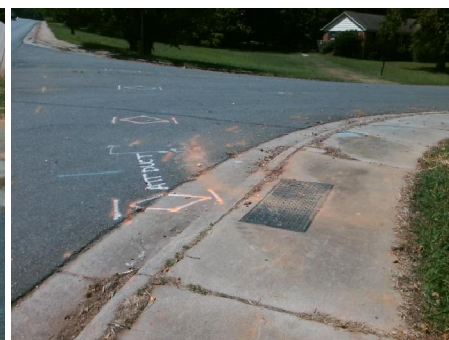
**Not Found, R304.5.1, R304.2.2**

Compliance	Description	Data	Compliance	Description	Data
N/A	Ramp Length (in)	59.0	No	Ramp Slope (%)	9.9
No	Ramp Width (in)	43.0	Yes	Ramp XSlope (%)	0.3
N/A	Flare Type LT	N/A	N/A	Flare Type RT	N/A
N/A	Flare Slope LT (%)	N/A	N/A	Flare Slope RT (%)	N/A
N/A	Flare Traversable LT?	N/A	N/A	Flare Traversable RT?	N/A
N/A	Landing Length (in)	N/A	N/A	DWS Provided?	N/A
N/A	Landing Width (in)	N/A	N/A	DWS Contrast?	N/A
N/A	Landing Slope (%)	N/A	N/A	DWS Length (in)	N/A
N/A	Landing X Slope (%)	N/A	N/A	DWS Full Width?	N/A
N/A	Landing Curb? (Y/N)	N/A	N/A	DWS Offset (in)	N/A
N/A	Shared Landing?	N/A			
N/A	Gutter Ponding?	N/A	N/A	Gutter Slope (%)	N/A
N/A	Gutter Lip Ht (in)	N/A	N/A	Gutter X Slope (%)	N/A
N/A	Painted X Walk1?	No	N/A	Painted X Walk2?	N/A
	X Walk 1 Direction	To W		X Walk 2 Direction	N/A
N/A	X Walk 1 Width (in)	N/A	N/A	X Walk 2 Width (in)	N/A
	X Walk 1 Slope (%)	5.4		X Walk 2 Slope (%)	N/A
	X Walk 1 X Slope (%)	1.7		X Walk 2 X Slope (%)	N/A

N/A	Ramp inside XWalk1?	N/A	N/A	Ramp inside XWalk2?	N/A
	Road Slope (%)	N/A	N/A	Clear Space?	N/A
	Road X Slope (%)	N/A	N/A	Clear Space to XWalk (in)	N/A
N/A	Any Obstructions?	N/A	N/A	Storm Grate/Utility Hazard?	N/A
	Obstruction Type			Storm Grate/Utility Type	
		N/A			N/A
			Yes	Surface Condition? (G/P)	Good

**Remove & Replace Entire Ramp.**

Total Cost: \$ 1850.00
