Access Compliance Report

Public Rights-of-Way

(Curb Ramps)

Intersection ID: 5574		Main Street: BANNER_ELK_DR		Cross Street: SUNSET_RD		Location: SE			
ADA ID: CCD94E28F8D5		Ramp Type: Directional1		Initial Pass/Fail: Pass		Overall Compliance: No		Severity Score: 7.5	
Codes/Mitigation Info/Possible Solution				Field Measurements/Component Compliance

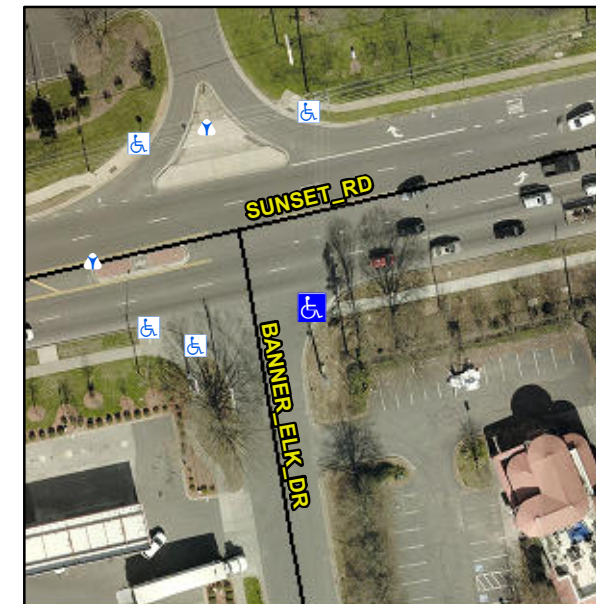
Compliance	Description	Data	Compliance	Description	Data
N/A	Ramp Length (in)	133.0	No	Grade Break?	No
Yes	Ramp Width (in)	69.0	N/A	Grade Break Slope (%)	N/A
Yes	Ramp Slope (%)	7.6	N/A	Grade Break XSlope (%)	N/A
Yes	Ramp XSlope (%)	1.3			
Yes	Flare Type LT	N/A	Yes	Flare Type RT	N/A
N/A	Flare Slope LT (%)	N/A	N/A	Flare Slope RT (%)	N/A
N/A	Flare Traversable LT?	No	N/A	Flare Traversable RT?	No
Yes	Landing Length (in)	59.0	Yes	DWS Provided?	Yes
Yes	Landing Width (in)	72.0	Yes	DWS Contrast?	Yes
Yes	Landing Slope (%)	0.7	Yes	DWS Length (in)	24.0
Yes	Landing X Slope (%)	0.9	Yes	DWS Full Width?	Yes
N/A	Landing Curb? (Y/N)	N/A	Yes	DWS Offset LT (in)	0.0
N/A	Shared Landing?	No	Yes	DWS Offset RT (in)	0.0
Yes	Gutter Ponding?	No	Yes	Gutter Slope (%)	0.1
No	Gutter Lip Ht (in)	0.5	Yes	Gutter X Slope (%)	0.8
N/A	Painted X Walk1?	No		Road Slope (%)	2.2
	X Walk 1 Direction	To W		Road X Slope (%)	3.7
	X Walk 1 Width (in)	N/A		Clear Space?	Yes

X Walk 1 Slope (%)	2.2	N/A	Clear Space to XWalk (in)	N/A
	X Walk 1 X Slope (%)	3.7	Yes	Storm Grate/Utility Hazard?	No
N/A	Ramp inside XWalk1?	N/A		Storm Grate/Utility Type	
Yes	Any Obstructions?	No			N/A
	Obstruction Type		Yes	Surface Condition? (G/P)	Good
			N/A	Curb Slope (%)	0.2

Possible Solutions:

**Remove & Replace Entire Ramp.
Grind Gutter Lip.**

R304.5.2, R302.7.2
