Access Compliance Report

Public Rights-of-Way (Curb Ramps)

Intersection ID: 10040544	Main Street: W_6TH_ST	Cross Street: N/A	Location: NW
ADA ID: CCDCEC93AFB6	Ramp Type: ParaDiag	Initial Pass/Fail: Fail	Overall Compliance: No
Codes/Mitigation Info/Possible Solution		Field Measurements/Component Compliance	
Severity Score: 25

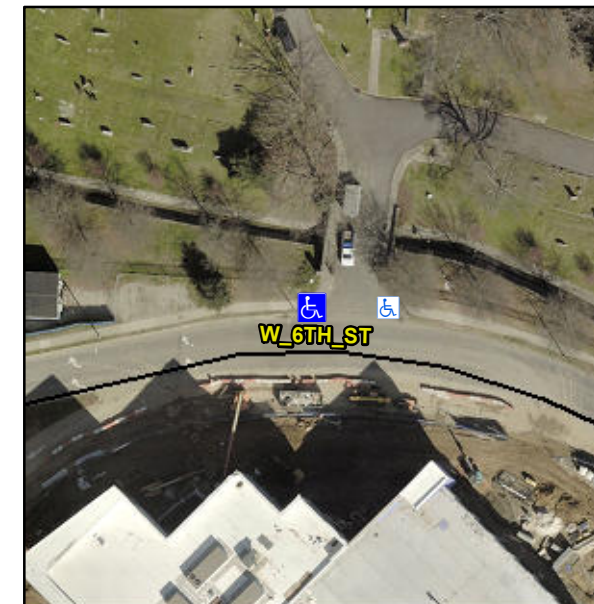
Compliance	Description	Data	Compliance	Description	Data
N/A	Ramp Length LT (in)	54.0	N/A	Ramp Length RT (in)	60.0
Yes	Ramp Width LT (in)	70.0	Yes	Ramp Width RT (in)	62.0
Yes	Ramp Slope LT (%)	5.6	No	Ramp Slope RT (%)	10.6
Yes	Ramp XSlope LT (%)	1.4	No	Ramp XSlope RT (%)	5.5
N/A	Landing Length (in)	N/A	N/A	DWS Provided?	N/A
N/A	Landing Width (in)	N/A	N/A	DWS Contrast?	N/A
N/A	Landing Slope (%)	N/A	N/A	DWS Length (in)	N/A
N/A	Landing X Slope (%)	N/A	N/A	DWS Full Width?	N/A
N/A	Landing Curb? (Y/N)	N/A	N/A	DWS Offset (in)	N/A
N/A	Shared Landing?	N/A			
N/A	Gutter Ponding?	N/A	N/A	Gutter Slope (%)	N/A
N/A	Gutter Lip Ht (in)	N/A	N/A	Gutter X Slope (%)	N/A
N/A	Painted X Walk1?	No	N/A	Painted X Walk2?	No
	X Walk 1 Direction	To S		X Walk 2 Direction	To E
N/A	X Walk 1 Width (in)	N/A	N/A	X Walk 2 Width (in)	N/A
	X Walk 1 Slope (%)	8.0		X Walk 2 Slope (%)	5.2
	X Walk 1 X Slope (%)	4.5		X Walk 2 X Slope (%)	1.8
N/A	Ramp inside XWalk1?	N/A	N/A	Ramp inside XWalk2?	N/A

Road Slope (%)	2.5	N/A	Clear Space?	N/A
	Road X Slope (%)	8.0	N/A	Clear Space to XWalk (in)	N/A
N/A	Any Obstructions?	N/A	N/A	Storm Grate/Utility Hazard?	N/A
	Obstruction Type			Storm Grate/Utility Type	
		N/A			N/A
			Yes	Surface Condition? (G/P)	Good
			N/A	Curb Slope (%)	9.8

Possible Solutions:

Remove & Replace Curb Ramp With Two New Directional Ramps or Equivalent.
