Access Compliance Report

Public Rights-of-Way

(Curb Ramps)

Intersection ID: 10019500	Main Street: ALICE_MCGINN_DR	Cross Street: N/A	Location: SE
ADA ID: CCEB704088E9	Ramp Type: Perp	Initial Pass/Fail: Fail	Overall Compliance: No
Severity Score: 13.75			
Codes/Mitigation Info/Possible Solution		Field Measurements/Component Compliance

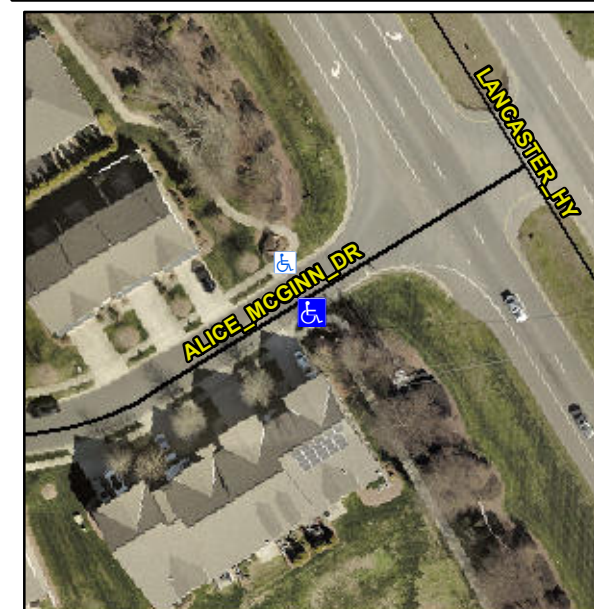
Not Found, R304.2.2

Compliance	Description	Data	Compliance	Description	Data
N/A	Ramp Length (in)	48.0	No	Ramp Slope (%)	8.7
Yes	Ramp Width (in)	48.0	Yes	Ramp XSlope (%)	3.4
N/A	Flare Type LT	N/A	N/A	Flare Type RT	N/A
N/A	Flare Slope LT (%)	N/A	N/A	Flare Slope RT (%)	N/A
N/A	Flare Traversable LT?	N/A	N/A	Flare Traversable RT?	N/A
N/A	Landing Length (in)	N/A	N/A	DWS Provided?	N/A
N/A	Landing Width (in)	N/A	N/A	DWS Contrast?	N/A
N/A	Landing Slope (%)	N/A	N/A	DWS Length (in)	N/A
N/A	Landing X Slope (%)	N/A	N/A	DWS Full Width?	N/A
N/A	Landing Curb? (Y/N)	N/A	N/A	DWS Offset (in)	N/A
N/A	Shared Landing?	N/A			
N/A	Gutter Ponding?	N/A	N/A	Gutter Slope (%)	N/A
N/A	Gutter Lip Ht (in)	N/A	N/A	Gutter X Slope (%)	N/A
N/A	Painted X Walk1?	No	N/A	Painted X Walk2?	N/A
	X Walk 1 Direction	To NW		X Walk 2 Direction	N/A
N/A	X Walk 1 Width (in)	N/A	N/A	X Walk 2 Width (in)	N/A
	X Walk 1 Slope (%)	2.4		X Walk 2 Slope (%)	N/A
	X Walk 1 X Slope (%)	4.1		X Walk 2 X Slope (%)	N/A

N/A	Ramp inside XWalk1?	N/A	N/A	Ramp inside XWalk2?	N/A
	Road Slope (%)	N/A	N/A	Clear Space?	N/A
	Road X Slope (%)	N/A	N/A	Clear Space to XWalk (in)	N/A
N/A	Any Obstructions?	N/A	N/A	Storm Grate/Utility Hazard?	N/A
	Obstruction Type			Storm Grate/Utility Type	
		N/A			N/A
			Yes	Surface Condition? (G/P)	Good

Possible Solutions:

Remove & Replace Entire Ramp.
