Access Compliance Report

Public Rights-of-Way

(Curb Ramps)

Intersection ID: 49396	Main Street: BARROSO_LN	Cross Street: ROMANA_RED_LN	Location: SE
ADA ID: CCF4290BDAAD	Ramp Type: PerpDiag	Initial Pass/Fail: Fail	Overall Compliance: No
Severity Score: 21.25			
Codes/Mitigation Info/Possible Solution		Field Measurements/Component Compliance

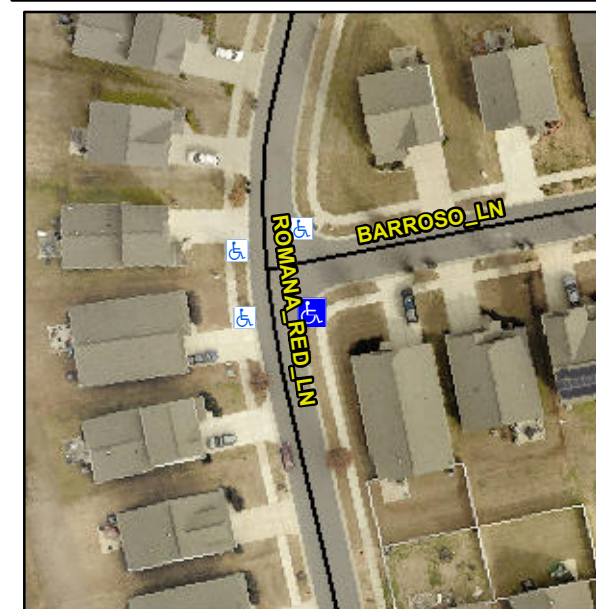
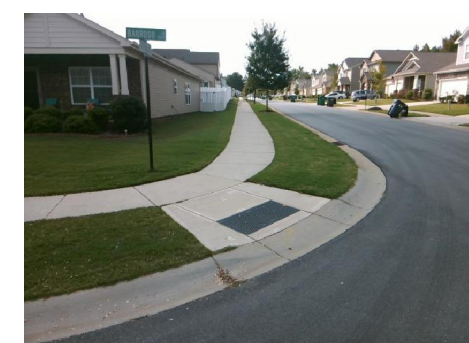
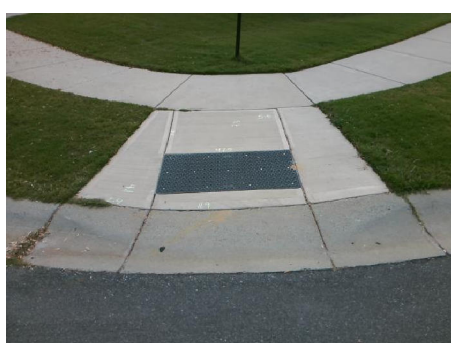
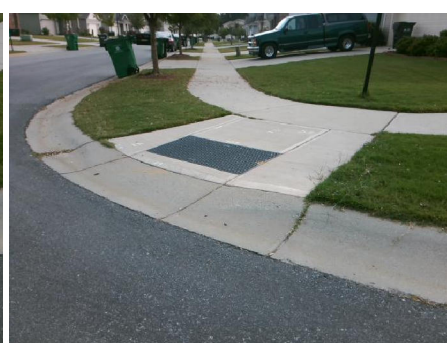
Not Found, R304.5.1, R304.5.3

Compliance	Description	Data	Compliance	Description	Data
N/A	Ramp Length (in)	71.0	Yes	Ramp Slope (%)	7.3
No	Ramp Width (in)	47.5	No	Ramp XSlope (%)	5.5
N/A	Flare Type LT	N/A	N/A	Flare Type RT	N/A
N/A	Flare Slope LT (%)	N/A	N/A	Flare Slope RT (%)	N/A
N/A	Flare Traversable LT?	N/A	N/A	Flare Traversable RT?	N/A
N/A	Landing Length (in)	N/A	N/A	DWS Provided?	N/A
N/A	Landing Width (in)	N/A	N/A	DWS Contrast?	N/A
N/A	Landing Slope (%)	N/A	N/A	DWS Length (in)	N/A
N/A	Landing X Slope (%)	N/A	N/A	DWS Full Width?	N/A
N/A	Landing Curb? (Y/N)	N/A	N/A	DWS Offset (in)	N/A
N/A	Shared Landing?	N/A			
N/A	Gutter Ponding?	N/A	N/A	Gutter Slope (%)	N/A
N/A	Gutter Lip Ht (in)	N/A	N/A	Gutter X Slope (%)	N/A
N/A	Painted X Walk1?	No	N/A	Painted X Walk2?	No
	X Walk 1 Direction	To N		X Walk 2 Direction	To W
N/A	X Walk 1 Width (in)	N/A	N/A	X Walk 2 Width (in)	N/A
	X Walk 1 Slope (%)	4.1		X Walk 2 Slope (%)	2.3
	X Walk 1 X Slope (%)	2.4		X Walk 2 X Slope (%)	2.1

N/A	Ramp inside XWalk1?	N/A	N/A	Ramp inside XWalk2?	N/A
	Road Slope (%)	6.0	N/A	Clear Space?	N/A
	Road X Slope (%)	2.6	N/A	Clear Space to XWalk (in)	N/A
N/A	Any Obstructions?	N/A	N/A	Storm Grate/Utility Hazard?	N/A
	Obstruction Type			Storm Grate/Utility Type	
		N/A			N/A
		Yes		Surface Condition? (G/P)	Good

Possible Solutions:

Remove & Replace Curb Ramp With Two New Directional Ramps or Equivalent.
