# Access Compliance Report

## Public Rights-of-Way

### (Curb Ramps)

Intersection ID: 10317	Main Street: E_32ND_ST	Cross Street: N_DAVIDSON_ST	Location: SE
ADA ID: CCF8F69FF2C3	Ramp Type: Directional1	Initial Pass/Fail: Fail	Overall Compliance: No
		Severity Score: 8.75	
Codes/Mitigation Info/Possible Solution		Field Measurements/Component Compliance

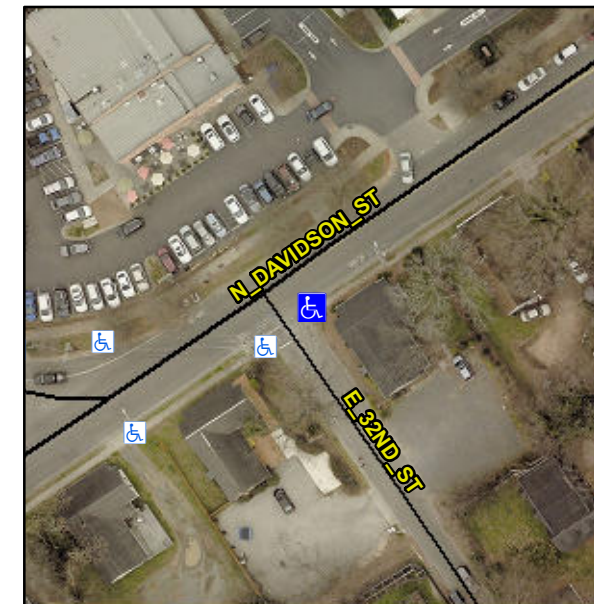
Compliance	Description	Data	Compliance	Description	Data
N/A	Ramp Length (in)	105.0	N/A	Grade Break?	N/A
No	Ramp Width (in)	46.0	N/A	Grade Break Slope (%)	0.0
Yes	Ramp Slope (%)	6.4	N/A	Grade Break XSlope (%)	0.0
Yes	Ramp XSlope (%)	1.5			
N/A	Flare Type LT	N/A	N/A	Flare Type RT	N/A
N/A	Flare Slope LT (%)	N/A	N/A	Flare Slope RT (%)	0.0
N/A	Flare Traversable LT?	N/A	N/A	Flare Traversable RT?	N/A
N/A	Landing Length (in)	0.0	N/A	DWS Provided?	N/A
N/A	Landing Width (in)	0.0	N/A	DWS Contrast?	N/A
N/A	Landing Slope (%)	0.0	N/A	DWS Length (in)	N/A
N/A	Landing X Slope (%)	0.0	N/A	DWS Full Width?	N/A
N/A	Landing Curb? (Y/N)	N/A	N/A	DWS Offset LT (in)	N/A
N/A	Shared Landing?	N/A	N/A	DWS Offset RT (in)	N/A
N/A	Gutter Ponding?	0.0	N/A	Gutter Slope (%)	N/A
N/A	Gutter Lip Ht (in)	0.0	N/A	Gutter X Slope (%)	N/A
N/A	Painted X Walk1?	Yes		Road Slope (%)	0.1
	X Walk 1 Direction	To SW		Road X Slope (%)	3.0
	X Walk 1 Width (in)	110.0		Clear Space?	N/A

X Walk 1 Slope (%)	0.1	N/A	Clear Space to XWalk (in)	N/A
	X Walk 1 X Slope (%)	3.0	N/A	Storm Grate/Utility Hazard?	N/A
N/A	Ramp inside XWalk1?	Yes		Storm Grate/Utility Type	
N/A	Any Obstructions?	N/A			N/A
	Obstruction Type		Yes	Surface Condition? (G/P)	Good
			N/A	Curb Slope (%)	24.7

Possible Solutions:

**Remove & Replace Entire Ramp.**
