# Access Compliance Report

## Public Rights-of-Way

### (Curb Ramps)

Intersection ID: 3131	Main Street: SANDMAN_LN	Cross Street: WALDEN_RIDGE_DR	Location: W
ADA ID: CCFCE6D0BFA0	Ramp Type: BlendTrans1	Initial Pass/Fail: Fail	Overall Compliance: No
		Severity Score: 8.75

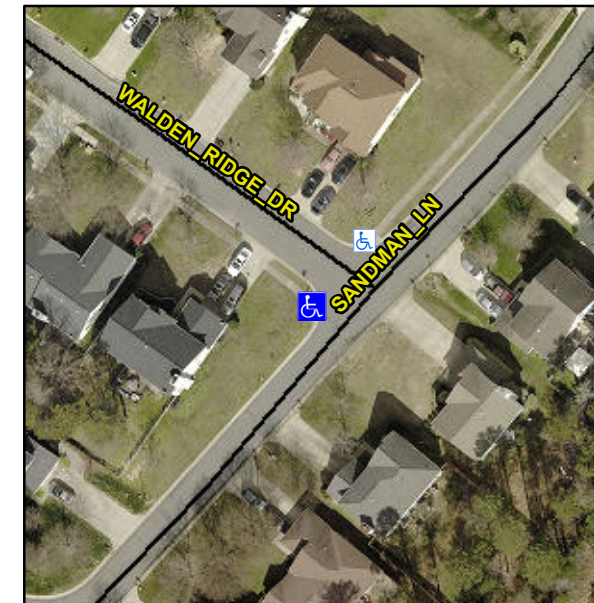
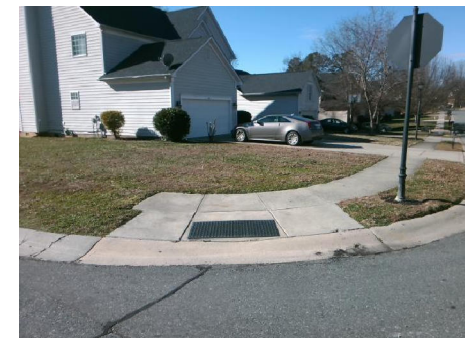
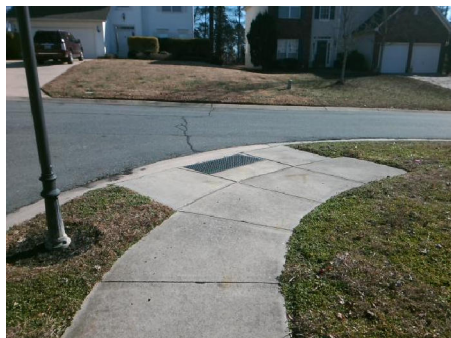
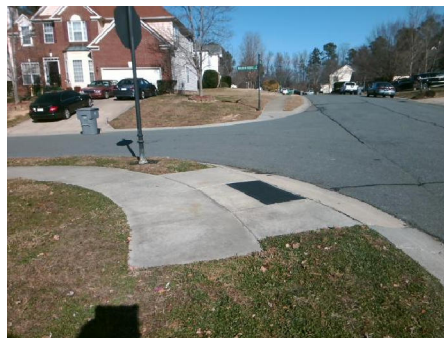
**Not Found, R304.5.1**

Compliance	Description	Data	Compliance	Description	Data
N/A	Ramp Length (in)	49.0	Yes	BlendTrans Slope (%)	3.3
No	Ramp Width (in)	47.0	Yes	BlendTrans XSlope (%)	0.0
N/A	Flare Type LT	N/A	N/A	Flare Type RT	N/A
N/A	Flare Slope LT (%)	N/A	N/A	Flare Slope RT (%)	N/A
N/A	Flare Traversable LT?	N/A	N/A	Flare Traversable RT?	N/A
N/A	Landing Length (in)	N/A	N/A	DWS Provided?	N/A
N/A	Landing Width (in)	N/A	N/A	DWS Contrast?	N/A
N/A	Landing Slope (%)	N/A	N/A	DWS Length (in)	N/A
N/A	Landing X Slope (%)	N/A	N/A	DWS Full Width?	N/A
N/A	Landing Curb? (Y/N)	N/A	N/A	DWS Offset (in)	N/A
N/A	Shared Landing?	N/A			
N/A	Gutter Ponding?	N/A	N/A	Gutter Slope (%)	N/A
N/A	Gutter Lip Ht (in)	N/A	N/A	Gutter X Slope (%)	N/A
N/A	Painted X Walk1?	No	N/A	Painted X Walk2?	N/A
	X Walk 1 Direction	To NE		X Walk 2 Direction	N/A
	X Walk 1 Width (in)	N/A		X Walk 2 Width (in)	N/A
	X Walk 1 Slope (%)	2.8		X Walk 2 Slope (%)	N/A
	X Walk 1 X Slope (%)	4.6		X Walk 2 X Slope (%)	N/A

N/A	Ramp inside XWalk1?	N/A	N/A	Ramp inside XWalk2?	N/A
	Road Slope (%)	4.6		Clear Space?	N/A
	Road X Slope (%)	2.8	N/A	Clear Space to XWalk (in)	N/A
N/A	Any Obstructions?	N/A	N/A	Storm Grate/Utility Hazard?	N/A
	Obstruction Type			Storm Grate/Utility Type	
		N/A			N/A
			Yes	Surface Condition? (G/P)	Good
			No	Curb Slope (%)	18.2

**Remove & Replace Curb Ramp With Two New Directional Ramps or Equivalent.**

Total Cost: \$ 3200.00
