Access Compliance Report

Public Rights-of-Way

(Curb Ramps)

Intersection ID: 3160	Main Street: BASKERVILLE_AV	Cross Street: CHISWELL_CT	Location: SE
ADA ID: CD0397837B7A	Ramp Type: Perp	Initial Pass/Fail: Fail	Overall Compliance: No
Severity Score: 12.5			
Codes/Mitigation Info/Possible Solution		Field Measurements/Component Compliance

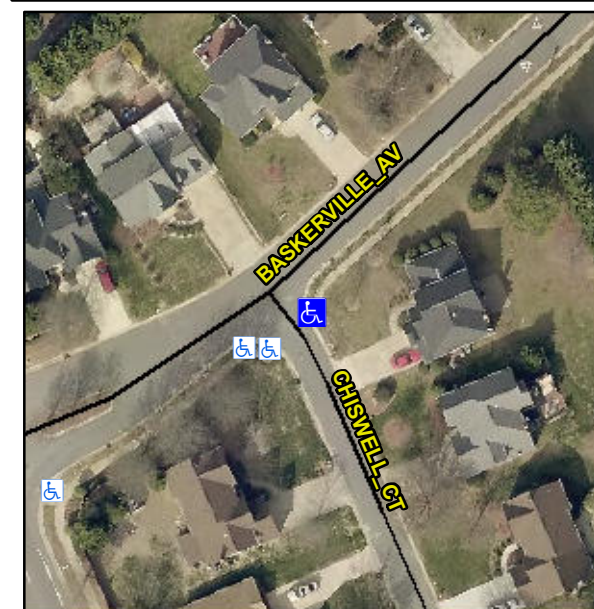
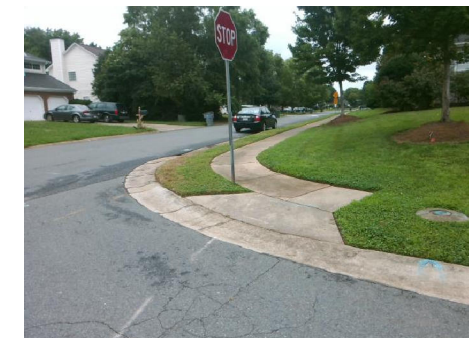
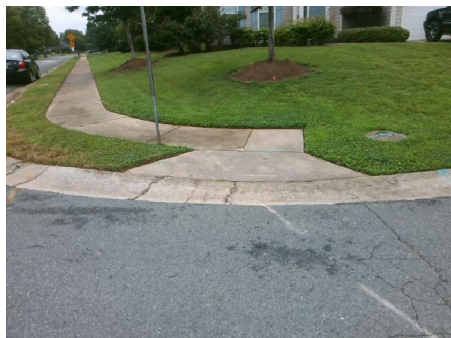
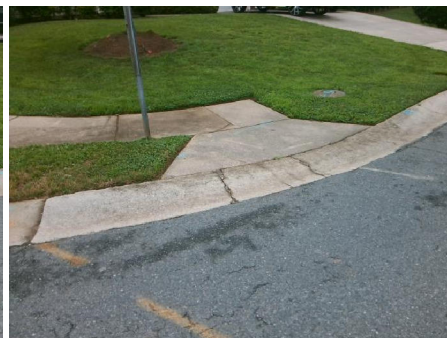
Not Found, R304.5.3

Compliance	Description	Data	Compliance	Description	Data
N/A	Ramp Length (in)	42.0	Yes	Ramp Slope (%)	5.1
Yes	Ramp Width (in)	58.0	No	Ramp XSlope (%)	5.1
N/A	Flare Type LT	N/A	N/A	Flare Type RT	N/A
N/A	Flare Slope LT (%)	N/A	N/A	Flare Slope RT (%)	N/A
N/A	Flare Traversable LT?	N/A	N/A	Flare Traversable RT?	N/A
N/A	Landing Length (in)	N/A	N/A	DWS Provided?	N/A
N/A	Landing Width (in)	N/A	N/A	DWS Contrast?	N/A
N/A	Landing Slope (%)	N/A	N/A	DWS Length (in)	N/A
N/A	Landing X Slope (%)	N/A	N/A	DWS Full Width?	N/A
N/A	Landing Curb? (Y/N)	N/A	N/A	DWS Offset (in)	N/A
N/A	Shared Landing?	N/A			
N/A	Gutter Ponding?	N/A	N/A	Gutter Slope (%)	N/A
N/A	Gutter Lip Ht (in)	N/A	N/A	Gutter X Slope (%)	N/A
N/A	Painted X Walk1?	No	N/A	Painted X Walk2?	N/A
	X Walk 1 Direction	To W		X Walk 2 Direction	N/A
N/A	X Walk 1 Width (in)	N/A	N/A	X Walk 2 Width (in)	N/A
	X Walk 1 Slope (%)	2.4		X Walk 2 Slope (%)	N/A
	X Walk 1 X Slope (%)	2.7		X Walk 2 X Slope (%)	N/A

N/A	Ramp inside XWalk1?	N/A	N/A	Ramp inside XWalk2?	N/A
	Road Slope (%)	N/A	N/A	Clear Space?	N/A
	Road X Slope (%)	N/A	N/A	Clear Space to XWalk (in)	N/A
N/A	Any Obstructions?	N/A	N/A	Storm Grate/Utility Hazard?	N/A
	Obstruction Type			Storm Grate/Utility Type	
		N/A			N/A
		Yes		Surface Condition? (G/P)	Good

Remove & Replace Entire Ramp.

Total Cost: \$ 1850.00
