Access Compliance Report

Public Rights-of-Way (Curb Ramps)

Intersection ID: 2928	Main Street: PROSPERITY_CHURCH_RD	Cross Street: RIDGE_RD	Location: NW
ADA ID: CD2824373F98	Ramp Type: Perp	Initial Pass/Fail: Fail	Overall Compliance: No
		Severity Score: 12.5

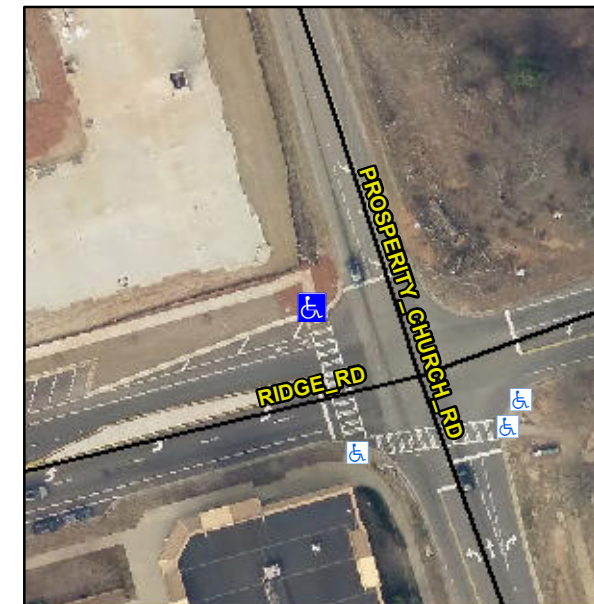
Compliance	Description	Data	Compliance	Description	Data
N/A	Ramp Length (in)	96.0	No	Ramp Slope (%)	11.2
Yes	Ramp Width (in)	71.0	Yes	Ramp XSlope (%)	0.9
N/A	Flare Type LT	N/A	N/A	Flare Type RT	N/A
N/A	Flare Slope LT (%)	N/A	N/A	Flare Slope RT (%)	N/A
N/A	Flare Traversable LT?	N/A	N/A	Flare Traversable RT?	N/A
N/A	Landing Length (in)	N/A	N/A	DWS Provided?	N/A
N/A	Landing Width (in)	N/A	N/A	DWS Contrast?	N/A
N/A	Landing Slope (%)	N/A	N/A	DWS Length (in)	N/A
N/A	Landing X Slope (%)	N/A	N/A	DWS Full Width?	N/A
N/A	Landing Curb? (Y/N)	N/A	N/A	DWS Offset (in)	N/A
N/A	Shared Landing?	N/A			
N/A	Gutter Ponding?	N/A	N/A	Gutter Slope (%)	N/A
N/A	Gutter Lip Ht (in)	N/A	N/A	Gutter X Slope (%)	N/A
N/A	Painted X Walk1?	Yes	N/A	Painted X Walk2?	N/A
	X Walk 1 Direction	To S		X Walk 2 Direction	N/A
N/A	X Walk 1 Width (in)	118.0	N/A	X Walk 2 Width (in)	N/A
	X Walk 1 Slope (%)	0.4		X Walk 2 Slope (%)	N/A
	X Walk 1 X Slope (%)	0.5		X Walk 2 X Slope (%)	N/A

Possible Solutions:

Remove & Replace Entire Ramp.
