# Access Compliance Report

## Public Rights-of-Way

### (Curb Ramps)

Intersection ID: 6172	Main Street: DOUBLE_SPRINGS_CT	Cross Street: RUMSTONE_LN	Location:	W
ADA ID: CD31FF8F618D	Ramp Type: Perp	Initial Pass/Fail: Fail	Overall Compliance: No	Severity Score: 8.75
Codes/Mitigation Info/Possible Solution		Field Measurements/Component Compliance

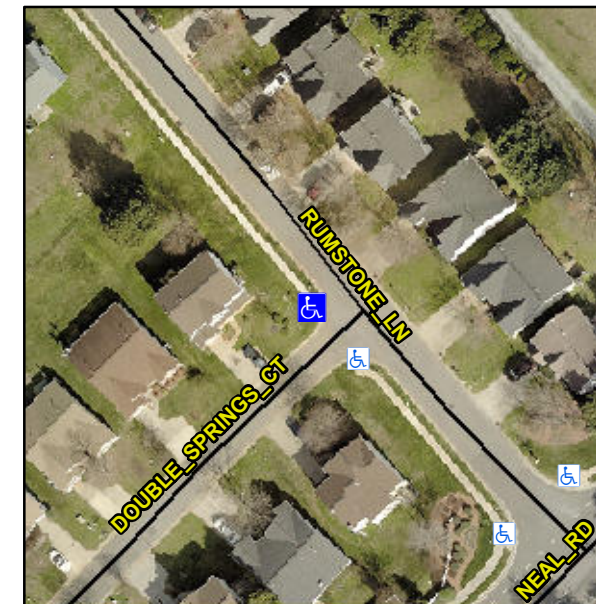
**Not Found, R304.5.1**

Compliance	Description	Data	Compliance	Description	Data
N/A	Ramp Length (in)	95.0	Yes	Ramp Slope (%)	7.4
No	Ramp Width (in)	46.0	Yes	Ramp XSlope (%)	1.6
N/A	Flare Type LT	N/A	N/A	Flare Type RT	N/A
N/A	Flare Slope LT (%)	N/A	N/A	Flare Slope RT (%)	N/A
N/A	Flare Traversable LT?	N/A	N/A	Flare Traversable RT?	N/A
N/A	Landing Length (in)	N/A	N/A	DWS Provided?	N/A
N/A	Landing Width (in)	N/A	N/A	DWS Contrast?	N/A
N/A	Landing Slope (%)	N/A	N/A	DWS Length (in)	N/A
N/A	Landing X Slope (%)	N/A	N/A	DWS Full Width?	N/A
N/A	Landing Curb? (Y/N)	N/A	N/A	DWS Offset (in)	N/A
N/A	Shared Landing?	N/A			
N/A	Gutter Ponding?	Yes	N/A	Gutter Slope (%)	N/A
N/A	Gutter Lip Ht (in)	N/A	N/A	Gutter X Slope (%)	N/A
N/A	Painted X Walk1?	No	N/A	Painted X Walk2?	N/A
	X Walk 1 Direction	To SE		X Walk 2 Direction	N/A
N/A	X Walk 1 Width (in)	N/A	N/A	X Walk 2 Width (in)	N/A
	X Walk 1 Slope (%)	0.2		X Walk 2 Slope (%)	N/A
	X Walk 1 X Slope (%)	1.0		X Walk 2 X Slope (%)	N/A

N/A	Ramp inside XWalk1?	N/A	N/A	Ramp inside XWalk2?	N/A
	Road Slope (%)	N/A	N/A	Clear Space?	N/A
	Road X Slope (%)	N/A	N/A	Clear Space to XWalk (in)	N/A
N/A	Any Obstructions?	N/A	N/A	Storm Grate/Utility Hazard?	N/A
	Obstruction Type			Storm Grate/Utility Type	
		N/A			N/A
			Yes	Surface Condition? (G/P)	Good

**Remove & Replace Entire Ramp.**

Total Cost: \$ 1850.00
