Access Compliance Report

Public Rights-of-Way

Intersection ID: 19923	Main Street: MCALPINE_PARK_DR	Cross Street: MCALPINE_STATION_DR	Location: NE
ADA ID: CD3F2A45E26D	Ramp Type: PerpDiag	Initial Pass/Fail: Fail	Overall Compliance: No
Severity Score: 22.5			
Codes/Mitigation Info/Possible Solution		Field Measurements/Component Compliance

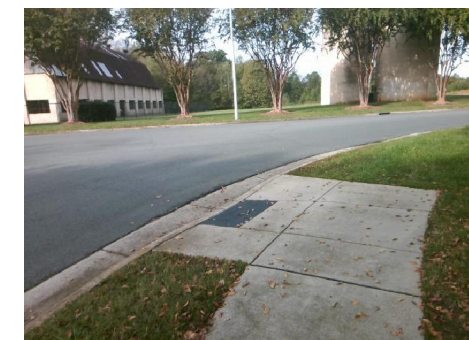
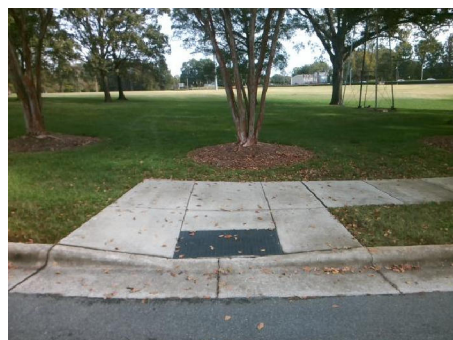
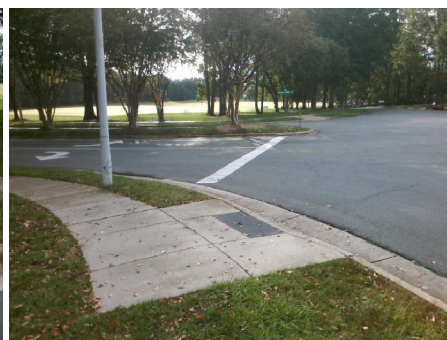
Compliance	Description	Data	Compliance	Description	Data
N/A	Ramp Length (in)	49.0	No	Ramp Slope (%)	8.7
No	Ramp Width (in)	47.0	No	Ramp XSlope (%)	3.2
N/A	Flare Type LT	N/A	N/A	Flare Type RT	N/A
N/A	Flare Slope LT (%)	N/A	N/A	Flare Slope RT (%)	N/A
N/A	Flare Traversable LT?	N/A	N/A	Flare Traversable RT?	N/A
N/A	Landing Length (in)	N/A	N/A	DWS Provided?	N/A
N/A	Landing Width (in)	N/A	N/A	DWS Contrast?	N/A
N/A	Landing Slope (%)	N/A	N/A	DWS Length (in)	N/A
N/A	Landing X Slope (%)	N/A	N/A	DWS Full Width?	N/A
N/A	Landing Curb? (Y/N)	N/A	N/A	DWS Offset (in)	N/A
N/A	Shared Landing?	N/A			
N/A	Gutter Ponding?	N/A	N/A	Gutter Slope (%)	N/A
N/A	Gutter Lip Ht (in)	N/A	N/A	Gutter X Slope (%)	N/A
N/A	Painted X Walk1?	No	N/A	Painted X Walk2?	No
	X Walk 1 Direction	To SW		X Walk 2 Direction	To SE
N/A	X Walk 1 Width (in)	N/A	N/A	X Walk 2 Width (in)	N/A
	X Walk 1 Slope (%)	4.4		X Walk 2 Slope (%)	1.8
	X Walk 1 X Slope (%)	1.3		X Walk 2 X Slope (%)	2.9

N/A	Ramp inside XWalk1?	N/A	N/A	Ramp inside XWalk2?	N/A
	Road Slope (%)	5.8	N/A	Clear Space?	N/A
	Road X Slope (%)	0.3	N/A	Clear Space to XWalk (in)	N/A
N/A	Any Obstructions?	N/A	N/A	Storm Grate/Utility Hazard?	N/A
	Obstruction Type			Storm Grate/Utility Type	
		N/A			N/A
			Yes	Surface Condition? (G/P)	Good

Remove & Replace Curb Ramp With Two New Directional Ramps or Equivalent.
