# Access Compliance Report

## Public Rights-of-Way (Curb Ramps)

Intersection ID: 10020684	Main Street: BEAM_RD	Cross Street: N/A	Location: NW
ADA ID: CD4626E1E962	Ramp Type: PerpDiag	Initial Pass/Fail: Fail	Overall Compliance: No
		Severity Score: 25

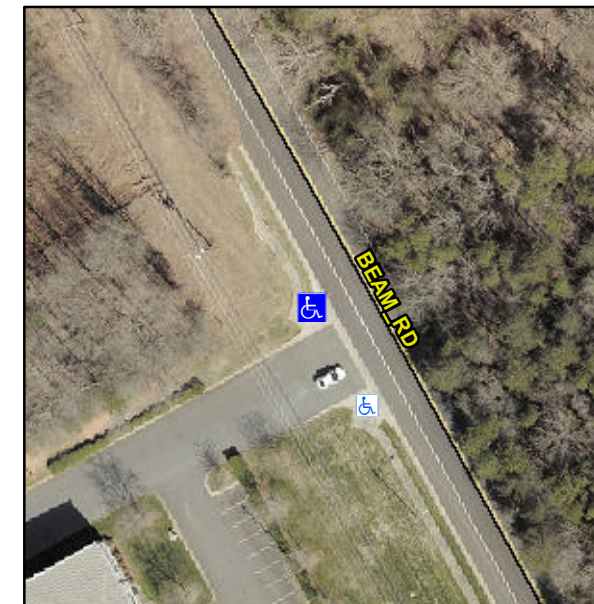
**Not Found, R304.5.3**

Compliance	Description	Data	Compliance	Description	Data
N/A	Ramp Length (in)	120.0	Yes	Ramp Slope (%)	6.9
Yes	Ramp Width (in)	54.0	No	Ramp XSlope (%)	8.4
N/A	Flare Type LT	N/A	N/A	Flare Type RT	N/A
N/A	Flare Slope LT (%)	N/A	N/A	Flare Slope RT (%)	N/A
N/A	Flare Traversable LT?	N/A	N/A	Flare Traversable RT?	N/A
N/A	Landing Length (in)	N/A	N/A	DWS Provided?	N/A
N/A	Landing Width (in)	N/A	N/A	DWS Contrast?	N/A
N/A	Landing Slope (%)	N/A	N/A	DWS Length (in)	N/A
N/A	Landing X Slope (%)	N/A	N/A	DWS Full Width?	N/A
N/A	Landing Curb? (Y/N)	N/A	N/A	DWS Offset (in)	N/A
N/A	Shared Landing?	N/A			
N/A	Gutter Ponding?	N/A	N/A	Gutter Slope (%)	N/A
N/A	Gutter Lip Ht (in)	N/A	N/A	Gutter X Slope (%)	N/A
N/A	Painted X Walk1?	No	N/A	Painted X Walk2?	No
	X Walk 1 Direction	To S		X Walk 2 Direction	To E
N/A	X Walk 1 Width (in)	N/A	N/A	X Walk 2 Width (in)	N/A
	X Walk 1 Slope (%)	0.4		X Walk 2 Slope (%)	1.9
	X Walk 1 X Slope (%)	6.1		X Walk 2 X Slope (%)	3.2

N/A	Ramp inside XWalk1?	N/A	N/A	Ramp inside XWalk2?	N/A
	Road Slope (%)	4.3	N/A	Clear Space?	N/A
	Road X Slope (%)	1.9	N/A	Clear Space to XWalk (in)	N/A
N/A	Any Obstructions?	N/A	N/A	Storm Grate/Utility Hazard?	N/A
	Obstruction Type			Storm Grate/Utility Type	
		N/A			N/A
		Yes		Surface Condition? (G/P)	Good

**Remove & Replace Curb Ramp With Two New Directional Ramps or Equivalent.**
