Access Compliance Report

Public Rights-of-Way

(Curb Ramps)

Intersection ID: 11566	Main Street: GRANDIN_RD	Cross Street: LITAKER_AV	Location: S
ADA ID: CD4E76D7EE5B	Ramp Type: Perp	Initial Pass/Fail: Fail	Overall Compliance: No
Severity Score: 13.75			
Codes/Mitigation Info/Possible Solution		Field Measurements/Component Compliance

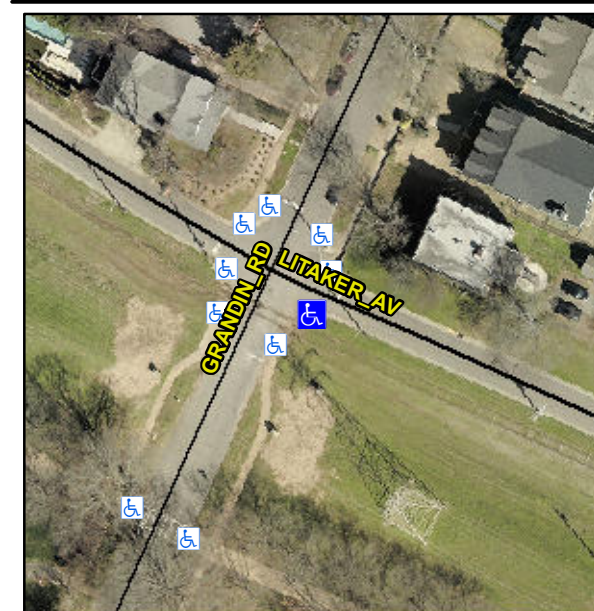
Not Found, R304.2.2, R304.5.3

Compliance	Description	Data	Compliance	Description	Data
N/A	Ramp Length (in)	54.0	No	Ramp Slope (%)	10.9
Yes	Ramp Width (in)	48.0	No	Ramp XSlope (%)	3.8
N/A	Flare Type LT	N/A	N/A	Flare Type RT	N/A
N/A	Flare Slope LT (%)	N/A	N/A	Flare Slope RT (%)	N/A
N/A	Flare Traversable LT?	N/A	N/A	Flare Traversable RT?	N/A
N/A	Landing Length (in)	N/A	N/A	DWS Provided?	N/A
N/A	Landing Width (in)	N/A	N/A	DWS Contrast?	N/A
N/A	Landing Slope (%)	N/A	N/A	DWS Length (in)	N/A
N/A	Landing X Slope (%)	N/A	N/A	DWS Full Width?	N/A
N/A	Landing Curb? (Y/N)	N/A	N/A	DWS Offset (in)	N/A
N/A	Shared Landing?	N/A			
N/A	Gutter Ponding?	N/A	N/A	Gutter Slope (%)	N/A
N/A	Gutter Lip Ht (in)	N/A	N/A	Gutter X Slope (%)	N/A
N/A	Painted X Walk1?	No	N/A	Painted X Walk2?	N/A
	X Walk 1 Direction	To NE		X Walk 2 Direction	N/A
N/A	X Walk 1 Width (in)	N/A	N/A	X Walk 2 Width (in)	N/A
	X Walk 1 Slope (%)	3.1		X Walk 2 Slope (%)	N/A
	X Walk 1 X Slope (%)	0.7		X Walk 2 X Slope (%)	N/A

Remove & Replace Entire Ramp.

Total Cost: \$ 1850.00
