## **Access Compliance Report Public Rights-of-Way** (Curb Ramps)

Intersection ID: 16545 Main Street: N SHARON AMITY RD Cross Street: MONROE\_RD Location: SW ADA ID: CD61C08B8BB3 Ramp Type: ParaDiag Initial Pass/Fail: Fail **Overall Compliance: No Severity Score:** 12.5

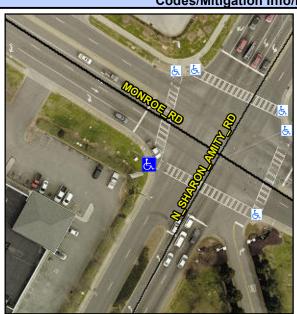
Compliance Description Data		Data	Compliance Description		Data
N/A	Ramp Length LT (in)	65.0	N/A	Ramp Length RT (in)	64.0
Yes	Ramp Width LT (in)	61.0	Yes	Ramp Width RT (in)	59.0
Yes	Ramp Slope LT (%)	5.7	No	Ramp Slope RT (%)	8.4
Yes	Ramp XSlope LT (%)	1.6	Yes	Ramp XSlope RT (%)	1.4
N/A	Landing Length (in)	N/A	N/A	DWS Provided?	N/A
N/A	Landing Width (in)	N/A	N/A	DWS Contrast?	N/A
N/A	Landing Slope (%)	N/A	N/A	DWS Length (in)	N/A
N/A	Landing X Slope (%)	N/A	N/A	DWS Full Width?	N/A
N/A	Landing Curb? (Y/N)	N/A	N/A	DWS Offset (in)	N/A
N/A	Shared Landing?	N/A			
N/A	Gutter Ponding?	N/A	N/A	Gutter Slope (%)	N/A
N/A	Gutter Lip Ht (in)	1.0	N/A	Gutter X Slope (%)	N/A
N/A	Painted X Walk1?	Yes	N/A	Painted X Walk2?	Yes
	X Walk 1 Direction	To SE		X Walk 2 Direction	To NE
N/A	X Walk 1 Width (in)	112.0	N/A	X Walk 2 Width (in)	117.0
	X Walk 1 Slope (%)	1.5		X Walk 2 Slope (%)	2.5
	X Walk 1 X Slope (%)	3.6		X Walk 2 X Slope (%)	1.9

N/A	Ramp inside XWalk1?	Yes	N/A	Ramp inside XWalk2?	Yes
	Road Slope (%)	1.2	N/A	Clear Space?	N/A
	Road X Slope (%)	5.3	N/A	Clear Space to XWalk (in)	N/A
N/A	Any Obstructions?	N/A	N/A	Storm Grate/Utility Hazard?	N/A
	Obstruction Type			Storm Grate/Utility Type	
		N/A			N/A
			Yes	Surface Condition? (G/P)	Good
			N/A	Curb Slope (%)	14.2
A A.	_

Possible Solutions: **Remove & Replace Curb Ramp With Two New Directional Ramps or** Equivalent. Surveyor Notes: N/A PROW/ADA: R304.3.2
