Access Compliance Report

Public Rights-of-Way

(Curb Ramps)

Intersection ID: 11000	Main Street: NC_MUSIC_FACTORY_BV	Cross Street: JOHNSON_ST	Location:	N
ADA ID: CD63B12DD4D0	Ramp Type: Directional1	Initial Pass/Fail: Fail	Overall Compliance: No	Severity Score: 12.5

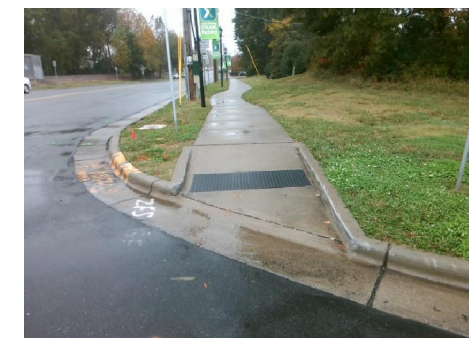
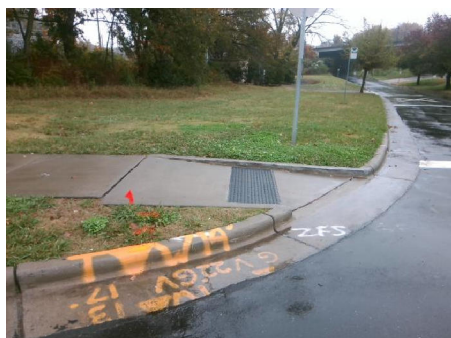
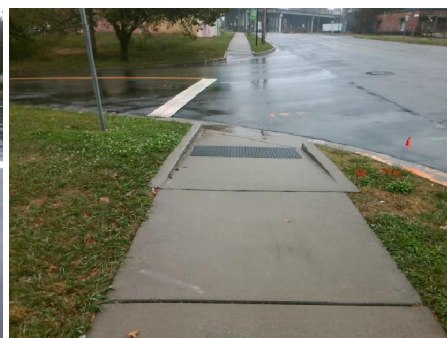
Compliance	Description	Data	Compliance	Description	Data
N/A	Ramp Length (in)	81.0	N/A	Grade Break?	N/A
Yes	Ramp Width (in)	67.5	N/A	Grade Break Slope (%)	0.0
No	Ramp Slope (%)	9.0	N/A	Grade Break XSlope (%)	0.0
Yes	Ramp XSlope (%)	1.0			
N/A	Flare Type LT	N/A	N/A	Flare Type RT	N/A
N/A	Flare Slope LT (%)	N/A	N/A	Flare Slope RT (%)	0.0
N/A	Flare Traversable LT?	N/A	N/A	Flare Traversable RT?	N/A
N/A	Landing Length (in)	0.0	N/A	DWS Provided?	N/A
N/A	Landing Width (in)	0.0	N/A	DWS Contrast?	N/A
N/A	Landing Slope (%)	0.0	N/A	DWS Length (in)	N/A
N/A	Landing X Slope (%)	0.0	N/A	DWS Full Width?	N/A
N/A	Landing Curb? (Y/N)	N/A	N/A	DWS Offset LT (in)	N/A
N/A	Shared Landing?	N/A	N/A	DWS Offset RT (in)	N/A
N/A	Gutter Ponding?	0.0	N/A	Gutter Slope (%)	N/A
N/A	Gutter Lip Ht (in)	0.0	N/A	Gutter X Slope (%)	N/A
N/A	Painted X Walk1?	No		Road Slope (%)	2.6
	X Walk 1 Direction	To E		Road X Slope (%)	4.7
	X Walk 1 Width (in)	N/A		Clear Space?	N/A

X Walk 1 Slope (%)	2.6	N/A	Clear Space to XWalk (in)	N/A
	X Walk 1 X Slope (%)	4.7	N/A	Storm Grate/Utility Hazard?	N/A
N/A	Ramp inside XWalk1?	N/A		Storm Grate/Utility Type	
N/A	Any Obstructions?	N/A			N/A
	Obstruction Type		Yes	Surface Condition? (G/P)	Good
			N/A	Curb Slope (%)	12.5

Remove & Replace Entire Ramp.
