Access Compliance Report

Public Rights-of-Way

(Curb Ramps)

Intersection ID: 13673	Main Street: CENTRAL_AV	Cross Street: CRYSTAL_RD	Location: SE
ADA ID: CD71538E9061	Ramp Type: Perp	Initial Pass/Fail: Fail	Overall Compliance: No
Severity Score: 21.25			
Codes/Mitigation Info/Possible Solution		Field Measurements/Component Compliance

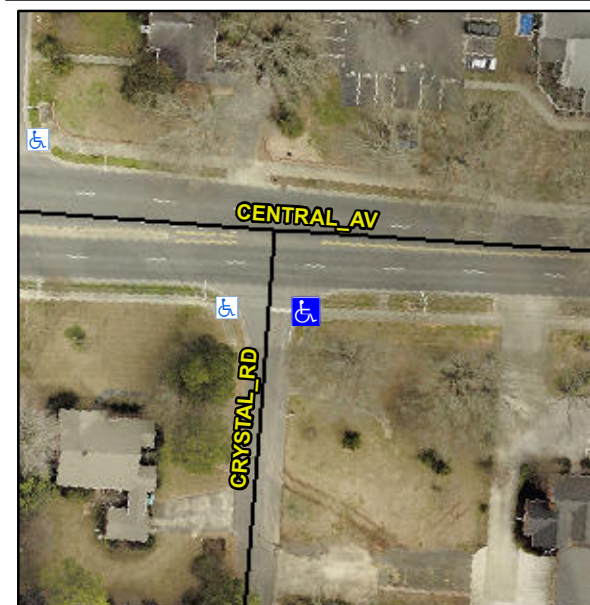
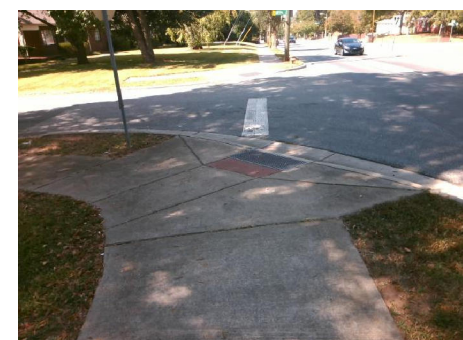
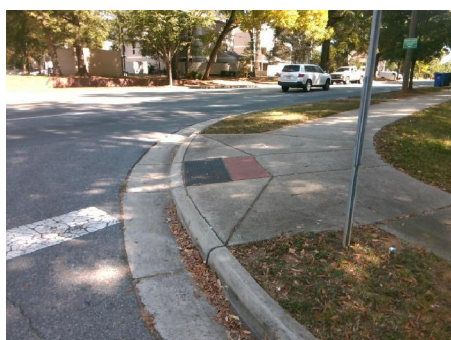
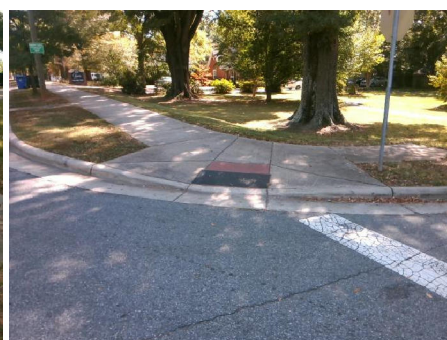
Not Found, R304.5.1, R304.5.3

Compliance	Description	Data	Compliance	Description	Data
N/A	Ramp Length (in)	48.0	Yes	Ramp Slope (%)	6.7
No	Ramp Width (in)	42.0	No	Ramp XSlope (%)	5.5
N/A	Flare Type LT	N/A	N/A	Flare Type RT	N/A
N/A	Flare Slope LT (%)	N/A	N/A	Flare Slope RT (%)	N/A
N/A	Flare Traversable LT?	N/A	N/A	Flare Traversable RT?	N/A
N/A	Landing Length (in)	N/A	N/A	DWS Provided?	N/A
N/A	Landing Width (in)	N/A	N/A	DWS Contrast?	N/A
N/A	Landing Slope (%)	N/A	N/A	DWS Length (in)	N/A
N/A	Landing X Slope (%)	N/A	N/A	DWS Full Width?	N/A
N/A	Landing Curb? (Y/N)	N/A	N/A	DWS Offset (in)	N/A
N/A	Shared Landing?	N/A			
N/A	Gutter Ponding?	N/A	N/A	Gutter Slope (%)	N/A
N/A	Gutter Lip Ht (in)	N/A	N/A	Gutter X Slope (%)	N/A
N/A	Painted X Walk1?	No	N/A	Painted X Walk2?	N/A
	X Walk 1 Direction	To W		X Walk 2 Direction	N/A
N/A	X Walk 1 Width (in)	N/A	N/A	X Walk 2 Width (in)	N/A
	X Walk 1 Slope (%)	0.5		X Walk 2 Slope (%)	N/A
	X Walk 1 X Slope (%)	4.9		X Walk 2 X Slope (%)	N/A

N/A	Ramp inside XWalk1?	N/A	N/A	Ramp inside XWalk2?	N/A
	Road Slope (%)	N/A	N/A	Clear Space?	N/A
	Road X Slope (%)	N/A	N/A	Clear Space to XWalk (in)	N/A
N/A	Any Obstructions?	N/A	N/A	Storm Grate/Utility Hazard?	N/A
	Obstruction Type			Storm Grate/Utility Type	
		N/A			N/A
			Yes	Surface Condition? (G/P)	Good

Possible Solutions:

Remove & Replace Entire Ramp.

Total Cost: \$ 1850.00
