Access Compliance Report Public Rights-of-Way (Curb Ramps)

Intersection ID: 54204 Main Street: APRIL_YIXUAN_LN Cross Street: N_TRYON_ST Location: NW **Overall Compliance: No** ADA ID: CD7189BC542E Ramp Type: Perp Initial Pass/Fail: Fail **Severity Score:** 1.25

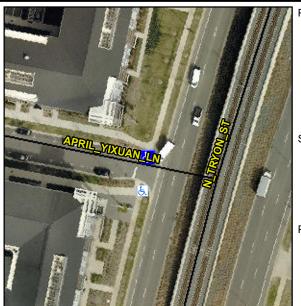
Compliance Description		Data	Comp	liance	Description	Data
N/A	Ramp Length (in)	96.0	Yes	Ramp	Slope (%)	7.9
Yes	Ramp Width (in)	48.0	No	Ramp	XSlope (%)	3.1
N/A	Flare Type LT	N/A	N/A	Flare	Type RT	N/A
N/A	Flare Slope LT (%)	N/A	N/A	Flare	Slope RT (%)	N/A
N/A	Flare Traversable LT?	N/A	N/A	Flare	Traversable RT?	N/A
N/A	Landing Length (in)	N/A	N/A	DWS	Provided?	N/A
N/A	Landing Width (in)	N/A	N/A	DWS	Contrast?	N/A
N/A	Landing Slope (%)	N/A	N/A	DWS	Length (in)	N/A
N/A	Landing X Slope (%)	N/A	N/A	DWS	Full Width?	N/A
N/A	Landing Curb? (Y/N)	N/A	N/A	DWS	Offset (in)	N/A
N/A	Shared Landing?	N/A				
N/A	Gutter Ponding?	N/A	N/A	Gutte	r Slope (%)	N/A
N/A	Gutter Lip Ht (in)	N/A	N/A	Gutte	r X Slope (%)	N/A
N/A	Painted X Walk1?	No	N/A	Paint	ed X Walk2?	N/A
	X Walk 1 Direction	To S		X Wa	lk 2 Direction	N/A
N/A	X Walk 1 Width (in)	N/A	N/A	X Wa	lk 2 Width (in)	N/A
	X Walk 1 Slope (%)	0.1		X Wa	lk 2 Slope (%)	N/A
	X Walk 1 X Slope (%)	2.8		X Wa	lk 2 X Slope (%)	N/A

N/A	Ramp inside XWalk1?	N/A	N/A	Ramp	inside XWalk2?	N/A
	Road Slope (%)	N/A	N/A	Clear	Space?	N/A
	Road X Slope (%)	N/A	N/A	Clear	Space to XWalk (in)	N/A
N/A	Any Obstructions?	N/A	N/A	Storm	n Grate/Utility Hazard?	N/A
	Obstruction Type			Storm	n Grate/Utility Type	
		N/A				N/A
			Yes	Surfa	ce Condition? (G/P)	Good

<u> </u>	COSIDIC COIGHON	
F	Possible Solutions:	Com
	Remove & Replace Entire Ramp.	N/A
		Yes
ř		N/A
į		N/A
		N/A
		N/A
5	Surveyor Notes:	N/A
į	N/A	N/A
		N/A
į		N/A
		N/A
F	PROW/ADA:	N/A
	Not Found, R304.5.3	N/A

Surveyor Notes:			N/A
N/A			N/A
			N/A
			N/A
			N/A
PROW/ADA:			N/A
Not Found, R304.5.3			N/A
			N/A
			N/A
			N/A
Total Cost:	\$	1850.00	N/A
Total Cost.	Ψ	1030.00
