# Access Compliance Report

## Public Rights-of-Way

### (Curb Ramps)

Intersection ID: 18518	Main Street: MURRAYHILL_RD	Cross Street: WEDGEWOOD_DR	Location: SW
ADA ID: CD7E4784EDA0	Ramp Type: Directional1	Initial Pass/Fail: Fail	Overall Compliance: No
Severity Score: 1.25			
Codes/Mitigation Info/Possible Solution		Field Measurements/Component Compliance

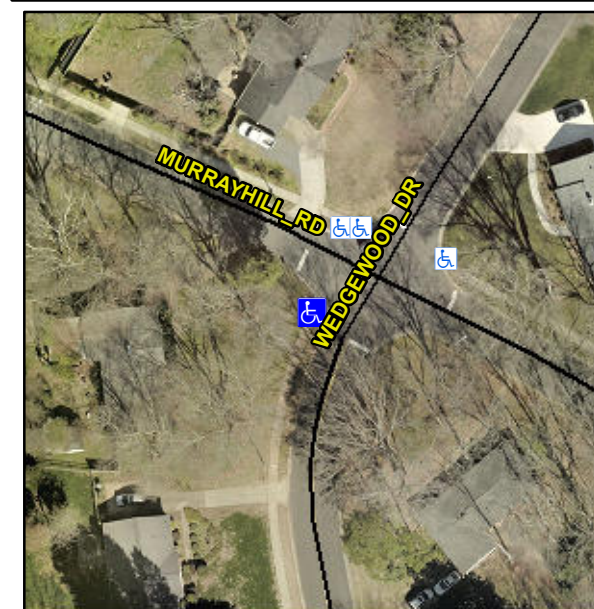
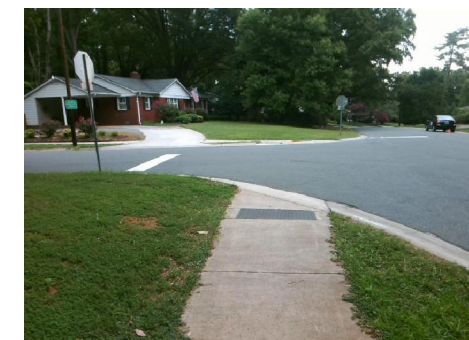
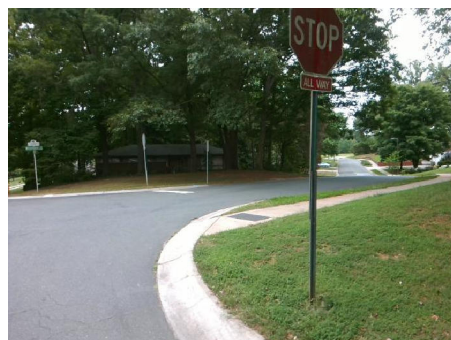
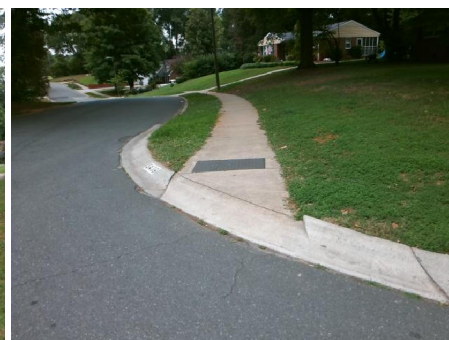
Compliance	Description	Data	Compliance	Description	Data
N/A	Ramp Length (in)	24.0	N/A	Grade Break?	N/A
Yes	Ramp Width (in)	66.0	N/A	Grade Break Slope (%)	0.0
Yes	Ramp Slope (%)	6.6	N/A	Grade Break XSlope (%)	0.0
No	Ramp XSlope (%)	2.5			
N/A	Flare Type LT	N/A	N/A	Flare Type RT	N/A
N/A	Flare Slope LT (%)	N/A	N/A	Flare Slope RT (%)	0.0
N/A	Flare Traversable LT?	N/A	N/A	Flare Traversable RT?	N/A
N/A	Landing Length (in)	0.0	N/A	DWS Provided?	N/A
N/A	Landing Width (in)	0.0	N/A	DWS Contrast?	N/A
N/A	Landing Slope (%)	0.0	N/A	DWS Length (in)	N/A
N/A	Landing X Slope (%)	0.0	N/A	DWS Full Width?	N/A
N/A	Landing Curb? (Y/N)	N/A	N/A	DWS Offset LT (in)	N/A
N/A	Shared Landing?	N/A	N/A	DWS Offset RT (in)	N/A
N/A	Gutter Ponding?	0.0	N/A	Gutter Slope (%)	N/A
N/A	Gutter Lip Ht (in)	0.0	N/A	Gutter X Slope (%)	N/A
N/A	Painted X Walk1?	No		Road Slope (%)	2.7
	X Walk 1 Direction	To N		Road X Slope (%)	0.6
	X Walk 1 Width (in)	N/A		Clear Space?	N/A

X Walk 1 Slope (%)	2.7	N/A	Clear Space to XWalk (in)	N/A
	X Walk 1 X Slope (%)	0.6	N/A	Storm Grate/Utility Hazard?	N/A
N/A	Ramp inside XWalk1?	N/A		Storm Grate/Utility Type	
N/A	Any Obstructions?	N/A			N/A
	Obstruction Type		Yes	Surface Condition? (G/P)	Good
			N/A	Curb Slope (%)	17.6

Possible Solutions:

**Remove & Replace Entire Ramp.**

**R304.5.3**

\$ 1600.00
