## **Access Compliance Report Public Rights-of-Way** (Curb Ramps)

Intersection ID: 2869 Main Street: EDINMEADOW LN Cross Street: RIDGE\_RD Location: NE **Overall Compliance: No** ADA ID: CD7E77318565 Ramp Type: Perp Initial Pass/Fail: Fail Severity Score: 33.75

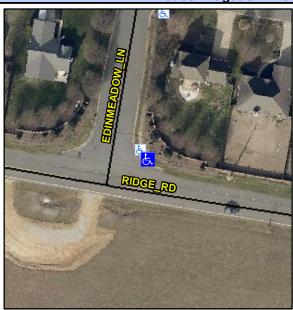
10.2

5.3

Ramp Slope (%)

Ramp XSlope (%)

Possible Solutions:	Compli	ance	Description	
Remove & Replace Entire Ramp.	N/A	Ramp Length (in)		
·	No	Ramp Width (in)		
	N/A	Flare	Type LT	
	N/A	Flare	,	
	N/A	Flare	Traversable LT	
	N/A	Land	ing Length (in)	
Surveyor Notes:	N/A	Land	ing Width (in)	
N/A	N/A	Land	ing Slope (%)	
	N/A	Land	ing X Slope (%)	
	N/A	Land	ing Curb? (Y/N)	
	N/A	Share	ed Landing?	
PROW/ADA:	N/A	Gutte	er Ponding?	
R304.5.1, R304.2.2, R304.5.3	N/A	Gutte	er Lip Ht (in)	
	N/A	Paint	ed X Walk1?	
		X Wa	lk 1 Direction	
	N/A	X Wa	lk 1 Width (in)	
		X Wa	lk 1 Slope (%)	
		X Wa	lk 1 X Slope (%	
	N/A	Ram	o inside XWalk1	
		Road	Slope (%)
