Access Compliance Report

Public Rights-of-Way

(Curb Ramps)

Intersection ID: 3749	Main Street: FOUNTAINGROVE_DR	Cross Street: PRIORY_CT	Location: S
ADA ID: CD8024BFE083	Ramp Type: Perp	Initial Pass/Fail: Fail	Overall Compliance: No
Codes/Mitigation Info/Possible Solution		Field Measurements/Component Compliance	
Severity Score: 18.75

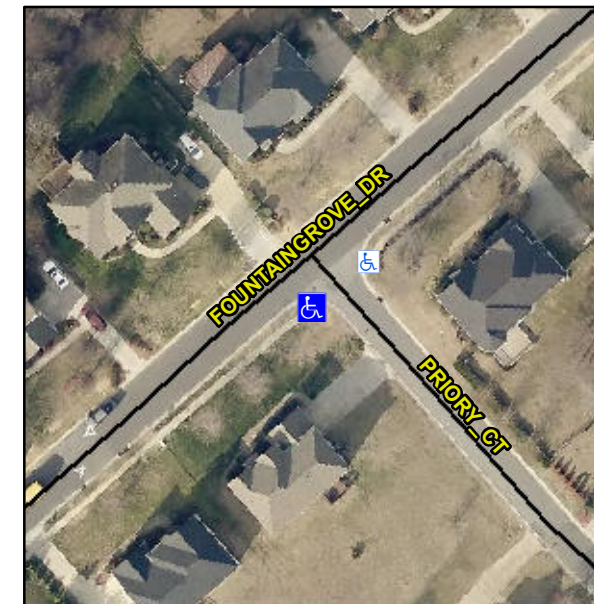
Not Found, R304.5.1, R304.5.3

Compliance	Description	Data	Compliance	Description	Data
N/A	Ramp Length (in)	46.0	Yes	Ramp Slope (%)	6.3
No	Ramp Width (in)	34.0	No	Ramp XSlope (%)	3.9
N/A	Flare Type LT	N/A	N/A	Flare Type RT	N/A
N/A	Flare Slope LT (%)	N/A	N/A	Flare Slope RT (%)	N/A
N/A	Flare Traversable LT?	N/A	N/A	Flare Traversable RT?	N/A
N/A	Landing Length (in)	N/A	N/A	DWS Provided?	N/A
N/A	Landing Width (in)	N/A	N/A	DWS Contrast?	N/A
N/A	Landing Slope (%)	N/A	N/A	DWS Length (in)	N/A
N/A	Landing X Slope (%)	N/A	N/A	DWS Full Width?	N/A
N/A	Landing Curb? (Y/N)	N/A	N/A	DWS Offset (in)	N/A
N/A	Shared Landing?	N/A			
N/A	Gutter Ponding?	N/A	N/A	Gutter Slope (%)	N/A
N/A	Gutter Lip Ht (in)	N/A	N/A	Gutter X Slope (%)	N/A
N/A	Painted X Walk1?	No	N/A	Painted X Walk2?	N/A
	X Walk 1 Direction	To NE		X Walk 2 Direction	N/A
N/A	X Walk 1 Width (in)	N/A	N/A	X Walk 2 Width (in)	N/A
	X Walk 1 Slope (%)	4.1		X Walk 2 Slope (%)	N/A
	X Walk 1 X Slope (%)	2.2		X Walk 2 X Slope (%)	N/A

N/A	Ramp inside XWalk1?	N/A	N/A	Ramp inside XWalk2?	N/A
	Road Slope (%)	N/A	N/A	Clear Space?	N/A
	Road X Slope (%)	N/A	N/A	Clear Space to XWalk (in)	N/A
N/A	Any Obstructions?	N/A	N/A	Storm Grate/Utility Hazard?	N/A
	Obstruction Type			Storm Grate/Utility Type	
		N/A			N/A
			Yes	Surface Condition? (G/P)	Good

Possible Solutions:

Remove & Replace Entire Ramp.

Total Cost: \$ 1850.00
