Access Compliance Report

Public Rights-of-Way (Curb Ramps)

Intersection ID: 52450	Main Street: TRANQUIL_OAK_PL	Cross Street: MOSS_LN	Location: SW
ADA ID: CD8733217339	Ramp Type: Directional1	Initial Pass/Fail: Fail	Overall Compliance: No
Severity Score: 13.75			
Codes/Mitigation Info/Possible Solution		Field Measurements/Component Compliance

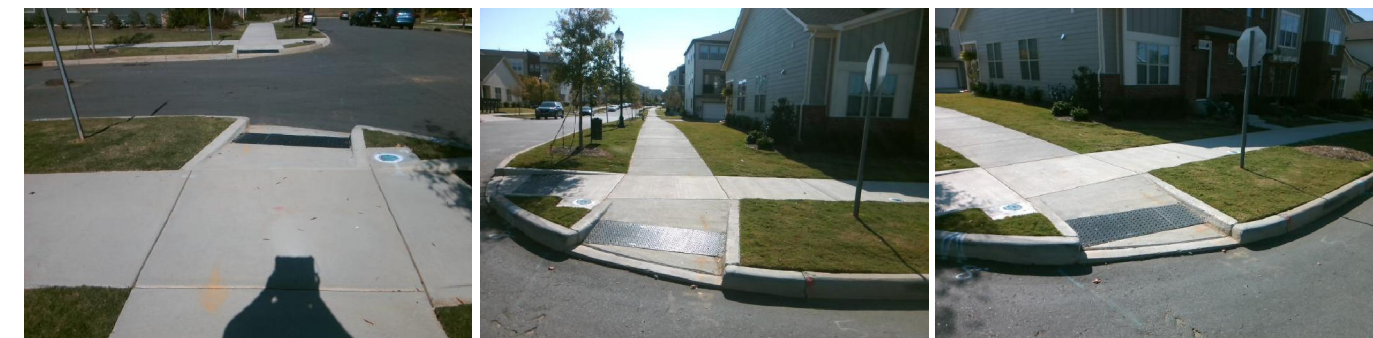
N/A	Shared Landing?	N/A	N/A	DWS Offset RT (in)	N/A
		N/A	Gutter Ponding?	0.0	N/A	Gutter Slope (%)	N/A
		N/A	Gutter Lip Ht (in)	2.5	N/A	Gutter X Slope (%)	N/A
		N/A	Painted X Walk1?	No		Road Slope (%)	1.2
			X Walk 1 Direction	To N		Road X Slope (%)	5.5
			X Walk 1 Width (in)	N/A		Clear Space?	N/A
			X Walk 1 Slope (%)	1.2	N/A	Clear Space to XWalk (in)	N/A
			X Walk 1 X Slope (%)	5.5	N/A	Storm Grate/Utility Hazard?	N/A
		N/A	Ramp inside XWalk1?	N/A		Storm Grate/Utility Type	
		N/A	Any Obstructions?	N/A			N/A
			Obstruction Type		Yes	Surface Condition? (G/P)	Good
				N/A	N/A	Curb Slope (%)	1.4

Possible Solutions:						
	Remove & Replace Entire Ramp.						
	Surveyor Notes:						
	N/A						
	PROW/ADA:						
	R304.2.2, R304.5.3						
	Street 1 Name	MOSS LN					
	Stop Condition-Street 1	StopSign					
	Street 2 Name	N/A					
	Stop Condition-Street 2	N/A					
Total Cost:		\$	1600.00				
		Compliance	Description	Data	Compliance	Description	Data
		N/A	Ramp Length (in)	57.0	N/A	Grade Break?	N/A
		Yes	Ramp Width (in)	65.0	N/A	Grade Break Slope (%)	0.0
		No	Ramp Slope (%)	9.7	N/A	Grade Break XSlope (%)	0.0
		No	Ramp XSlope (%)	4.7			
		N/A	Flare Type LT	N/A	N/A	Flare Type RT	N/A
		N/A	Flare Slope LT (%)	N/A	N/A	Flare Slope RT (%)	0.0
		N/A	Flare Traversable LT?	N/A	N/A	Flare Traversable RT?	N/A
		N/A	Landing Length (in)	0.0	N/A	DWS Provided?	N/A
		N/A	Landing Width (in)	0.0	N/A	DWS Contrast?	N/A
		N/A	Landing Slope (%)	0.0	N/A	DWS Length (in)	N/A
		N/A	Landing X Slope (%)	0.0	N/A	DWS Full Width?	N/A
		N/A	Landing Curb? (Y/N)	N/A	N/A	DWS Offset LT (in)	N/A
