Access Compliance Report

Public Rights-of-Way

(Curb Ramps)

Intersection ID: 13620	Main Street: SHENANDOAH_AV	Cross Street: THE_PLAZA	Location: E
ADA ID: CD881B491CC1	Ramp Type: BlendTrans1	Initial Pass/Fail: Fail	Overall Compliance: No
Severity Score: 8.75			
Codes/Mitigation Info/Possible Solution		Field Measurements/Component Compliance

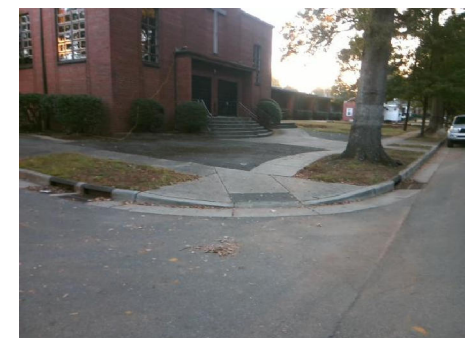
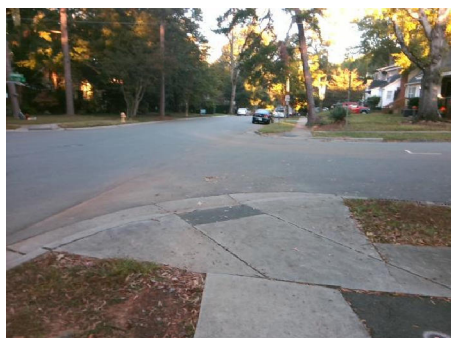
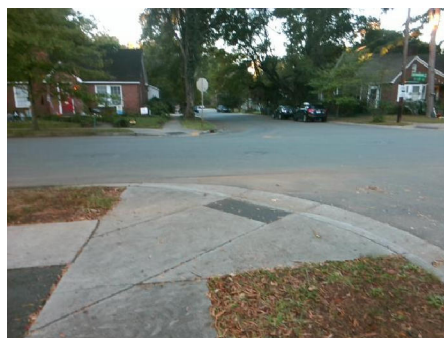
Not Found, R304.5.1

Compliance	Description	Data	Compliance	Description	Data
N/A	Ramp Length (in)	93.5	Yes	BlendTrans Slope (%)	4.2
No	Ramp Width (in)	47.5	Yes	BlendTrans XSlope (%)	0.2
N/A	Flare Type LT	N/A	N/A	Flare Type RT	N/A
N/A	Flare Slope LT (%)	N/A	N/A	Flare Slope RT (%)	N/A
N/A	Flare Traversable LT?	N/A	N/A	Flare Traversable RT?	N/A
N/A	Landing Length (in)	N/A	N/A	DWS Provided?	N/A
N/A	Landing Width (in)	N/A	N/A	DWS Contrast?	N/A
N/A	Landing Slope (%)	N/A	N/A	DWS Length (in)	N/A
N/A	Landing X Slope (%)	N/A	N/A	DWS Full Width?	N/A
N/A	Landing Curb? (Y/N)	N/A	N/A	DWS Offset (in)	N/A
N/A	Shared Landing?	N/A			
N/A	Gutter Ponding?	N/A	N/A	Gutter Slope (%)	N/A
N/A	Gutter Lip Ht (in)	N/A	N/A	Gutter X Slope (%)	N/A
N/A	Painted X Walk1?	No	N/A	Painted X Walk2?	No
	X Walk 1 Direction	To NW		X Walk 2 Direction	To SW
	X Walk 1 Width (in)	N/A		X Walk 2 Width (in)	N/A
	X Walk 1 Slope (%)	0.5		X Walk 2 Slope (%)	0.3
	X Walk 1 X Slope (%)	0.1		X Walk 2 X Slope (%)	0.6

N/A	Ramp inside XWalk1?	N/A	N/A	Ramp inside XWalk2?	N/A
	Road Slope (%)	1.3		Clear Space?	N/A
	Road X Slope (%)	0.3	N/A	Clear Space to XWalk (in)	N/A
N/A	Any Obstructions?	N/A	N/A	Storm Grate/Utility Hazard?	N/A
	Obstruction Type			Storm Grate/Utility Type	
		N/A			N/A
			Yes	Surface Condition? (G/P)	Good
			No	Curb Slope (%)	21.0

Remove & Replace Curb Ramp With Two New Directional Ramps or Equivalent.
