Access Compliance Report

Public Rights-of-Way

(Curb Ramps)

Intersection ID: 10025341	Main Street: E_7TH_ST	Cross Street: N/A	Location: N
ADA ID: CD98FF6C7387	Ramp Type: Perp	Initial Pass/Fail: Pass	Overall Compliance: No
Severity Score: 2.75			
Codes/Mitigation Info/Possible Solution		Field Measurements/Component Compliance

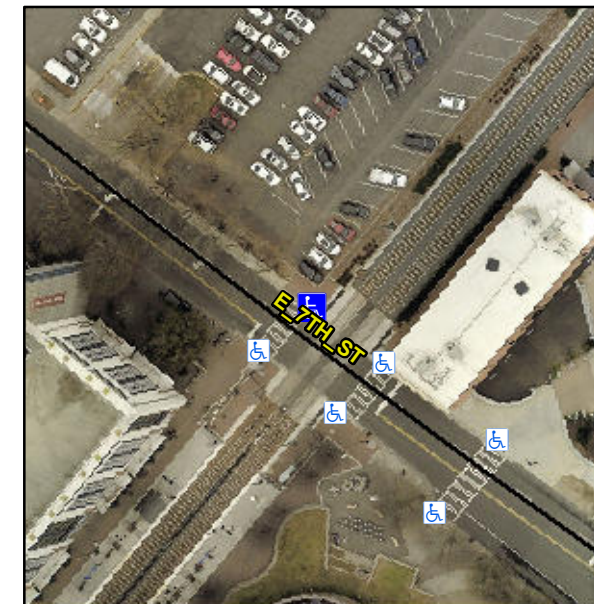
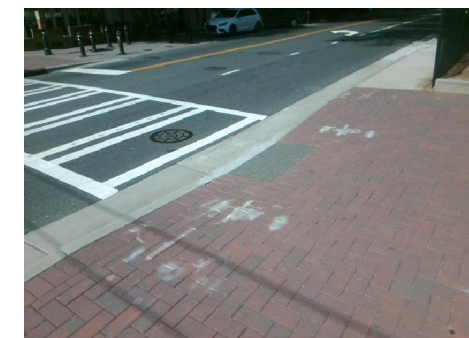
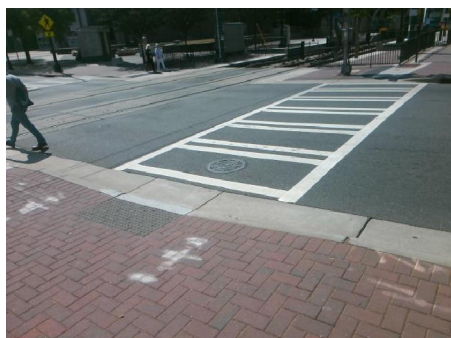
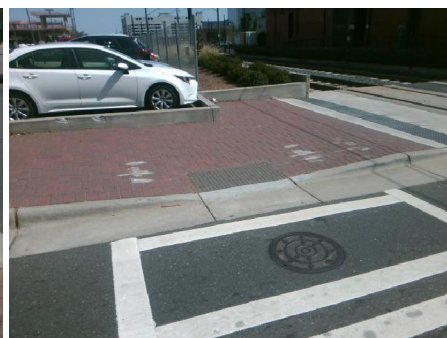
R304.2.1, R304.5.3, R304.2.3

Compliance	Description	Data	Compliance	Description	Data
N/A	Ramp Length (in)	70.0	Yes	Ramp Slope (%)	6.2
Yes	Ramp Width (in)	48.0	Yes	Ramp XSlope (%)	3.4
N/A	Flare Type LT	Sloped	N/A	Flare Type RT	N/A
N/A	Flare Slope LT (%)	11.6	Yes	Flare Slope RT (%)	4.4
N/A	Flare Traversable LT?	Yes	N/A	Flare Traversable RT?	Yes
No	Landing Length (in)	48.0	Yes	DWS Provided?	Yes
Yes	Landing Width (in)	48.0	Yes	DWS Contrast?	Yes
Yes	Landing Slope (%)	1.6	Yes	DWS Length (in)	24.0
No	Landing X Slope (%)	4.6	Yes	DWS Full Width?	Yes
N/A	Landing Curb? (Y/N)	Yes	Yes	DWS Offset (in)	0.0
N/A	Shared Landing?	No			
Yes	Gutter Ponding?	No	Yes	Gutter Slope (%)	2.9
Yes	Gutter Lip Ht (in)	0.0	Yes	Gutter X Slope (%)	2.9
N/A	Painted X Walk1?	Yes	N/A	Painted X Walk2?	N/A
	X Walk 1 Direction	To SW		X Walk 2 Direction	N/A
N/A	X Walk 1 Width (in)	112.0	N/A	X Walk 2 Width (in)	N/A
	X Walk 1 Slope (%)	1.0		X Walk 2 Slope (%)	N/A
	X Walk 1 X Slope (%)	4.1		X Walk 2 X Slope (%)	N/A

Yes	Ramp inside XWalk1?	Yes	N/A	Ramp inside XWalk2?	N/A
	Road Slope (%)	N/A	N/A	Clear Space?	Yes
	Road X Slope (%)	N/A	N/A	Clear Space to XWalk (in)	N/A
Yes	Any Obstructions?	No	Yes	Storm Grate/Utility Hazard?	No
	Obstruction Type			Storm Grate/Utility Type	
		N/A			N/A
			Yes	Surface Condition? (G/P)	Good

Remove & Replace Entire Ramp.
