# Access Compliance Report

## Public Rights-of-Way

| Intersection ID: 12763 | Main Street: S_BREVARD_ST | Cross Street: E_3RD_ST | Location: E |
| ADA ID: CDB01A019E8E | Ramp Type: PerpDiag | Initial Pass/Fail: Fail | Overall Compliance: No |

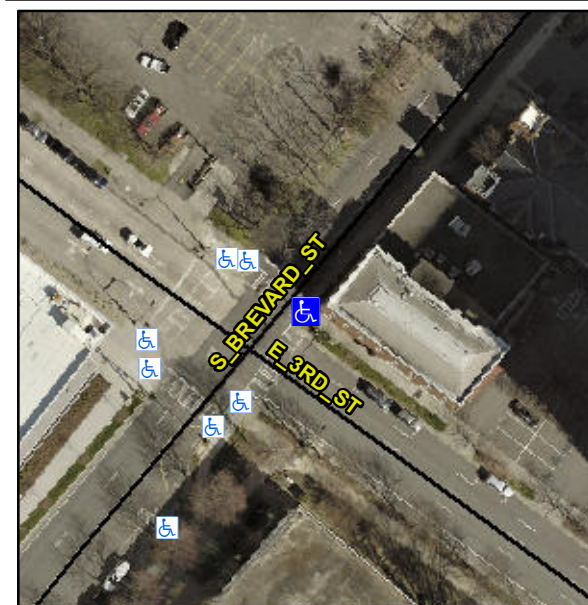
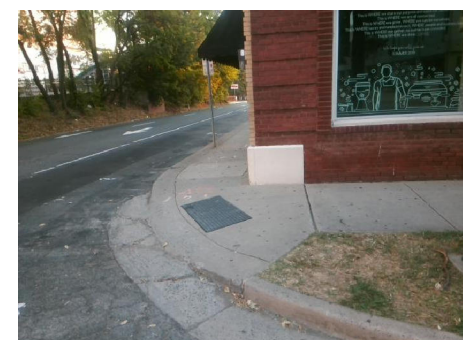
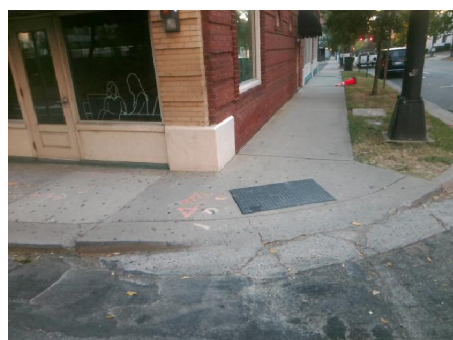
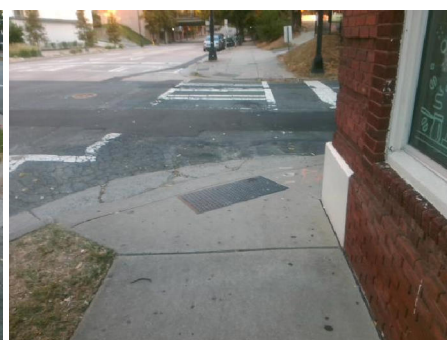
| Severity Score: 12.5 | | | |

**Not Found, R304.2.2**

| Compliance | Description | Data | Compliance | Description | Data |
|---|---|---|---|---|---|
| N/A | Ramp Length (in) | 48.0 | No | Ramp Slope (%) | 8.6 |

**Remove & Replace Curb Ramp With Two New Directional Ramps or Equivalent.**

Total Cost: \$ 3200.00
