Access Compliance Report

Public Rights-of-Way

(Curb Ramps)

Intersection ID: 46734	Main Street: BOBHOUSE_DR	Cross Street: THREATT_WOODS_DR	Location: NE
ADA ID: CDB989E76C2C	Ramp Type: PerpDiag	Initial Pass/Fail: Fail	Overall Compliance: No
Severity Score: 13.75			
Codes/Mitigation Info/Possible Solution		Field Measurements/Component Compliance

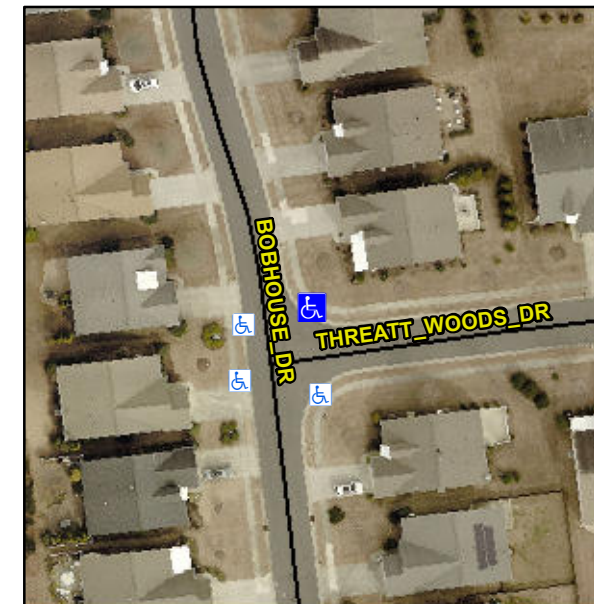
Not Found, R304.2.2, R304.5.3

Compliance	Description	Data	Compliance	Description	Data
N/A	Ramp Length (in)	48.5	No	Ramp Slope (%)	8.5
Yes	Ramp Width (in)	48.0	No	Ramp XSlope (%)	4.5
N/A	Flare Type LT	N/A	N/A	Flare Type RT	N/A
N/A	Flare Slope LT (%)	N/A	N/A	Flare Slope RT (%)	N/A
N/A	Flare Traversable LT?	N/A	N/A	Flare Traversable RT?	N/A
N/A	Landing Length (in)	N/A	N/A	DWS Provided?	N/A
N/A	Landing Width (in)	N/A	N/A	DWS Contrast?	N/A
N/A	Landing Slope (%)	N/A	N/A	DWS Length (in)	N/A
N/A	Landing X Slope (%)	N/A	N/A	DWS Full Width?	N/A
N/A	Landing Curb? (Y/N)	N/A	N/A	DWS Offset (in)	N/A
N/A	Shared Landing?	N/A			
N/A	Gutter Ponding?	N/A	N/A	Gutter Slope (%)	N/A
N/A	Gutter Lip Ht (in)	N/A	N/A	Gutter X Slope (%)	N/A
N/A	Painted X Walk1?	No	N/A	Painted X Walk2?	No
	X Walk 1 Direction	To W		X Walk 2 Direction	To S
N/A	X Walk 1 Width (in)	N/A	N/A	X Walk 2 Width (in)	N/A
	X Walk 1 Slope (%)	3.7		X Walk 2 Slope (%)	1.7
	X Walk 1 X Slope (%)	2.1		X Walk 2 X Slope (%)	2.6

N/A	Ramp inside XWalk1?	N/A	N/A	Ramp inside XWalk2?	N/A
	Road Slope (%)	3.5	N/A	Clear Space?	N/A
	Road X Slope (%)	1.1	N/A	Clear Space to XWalk (in)	N/A
N/A	Any Obstructions?	N/A	N/A	Storm Grate/Utility Hazard?	N/A
	Obstruction Type			Storm Grate/Utility Type	
		N/A			N/A
		Yes		Surface Condition? (G/P)	Good

Remove & Replace Curb Ramp With Two New Directional Ramps or Equivalent.
