Access Compliance Report

Public Rights-of-Way

(Curb Ramps)

Intersection ID: 15576	Main Street: LAWYERS_RD	Cross Street: IDLEWILD_RD_NORTH	Location: NE
ADA ID: CDC703F577A3	Ramp Type: PerpDiag	Initial Pass/Fail: Fail	Overall Compliance: No
		Severity Score: 8.75

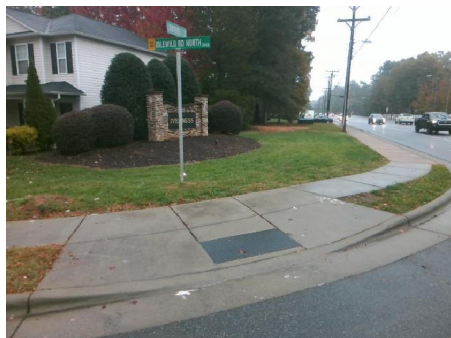
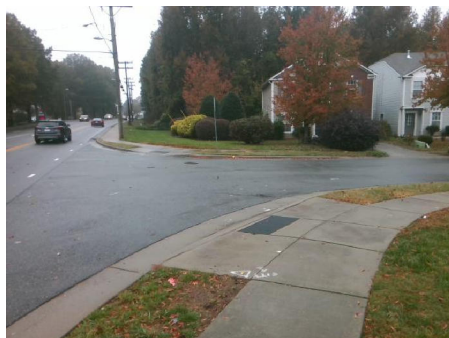
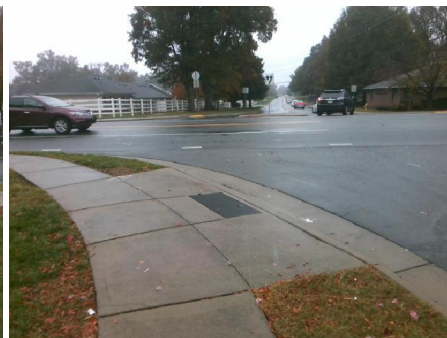
Compliance	Description	Data	Compliance	Description	Data
N/A	Ramp Length (in)	48.0	Yes	Ramp Slope (%)	7.0
No	Ramp Width (in)	47.0	Yes	Ramp XSlope (%)	2.0
N/A	Flare Type LT	N/A	N/A	Flare Type RT	N/A
N/A	Flare Slope LT (%)	N/A	N/A	Flare Slope RT (%)	N/A
N/A	Flare Traversable LT?	N/A	N/A	Flare Traversable RT?	N/A
N/A	Landing Length (in)	N/A	N/A	DWS Provided?	N/A
N/A	Landing Width (in)	N/A	N/A	DWS Contrast?	N/A
N/A	Landing Slope (%)	N/A	N/A	DWS Length (in)	N/A
N/A	Landing X Slope (%)	N/A	N/A	DWS Full Width?	N/A
N/A	Landing Curb? (Y/N)	N/A	N/A	DWS Offset (in)	N/A
N/A	Shared Landing?	N/A			
N/A	Gutter Ponding?	N/A	N/A	Gutter Slope (%)	N/A
N/A	Gutter Lip Ht (in)	N/A	N/A	Gutter X Slope (%)	N/A
N/A	Painted X Walk1?	No	N/A	Painted X Walk2?	No
	X Walk 1 Direction	To NW		X Walk 2 Direction	To SW
N/A	X Walk 1 Width (in)	N/A	N/A	X Walk 2 Width (in)	N/A
	X Walk 1 Slope (%)	1.1		X Walk 2 Slope (%)	2.8
	X Walk 1 X Slope (%)	3.8		X Walk 2 X Slope (%)	0.7

N/A	Ramp inside XWalk1?	N/A	N/A	Ramp inside XWalk2?	N/A
	Road Slope (%)	2.8	N/A	Clear Space?	N/A
	Road X Slope (%)	0.9	N/A	Clear Space to XWalk (in)	N/A
N/A	Any Obstructions?	N/A	N/A	Storm Grate/Utility Hazard?	N/A
	Obstruction Type			Storm Grate/Utility Type	
		N/A			N/A
			Yes	Surface Condition? (G/P)	Good

Remove & Replace Curb Ramp With Two New Directional Ramps or Equivalent.
