Access Compliance Report

Public Rights-of-Way

(Curb Ramps)

Intersection ID: 12977	Main Street: W_PALMER_ST	Cross Street: S_CHURCH_ST	Location: NW
ADA ID: CDCD2340D363	Ramp Type: PerpDiag	Initial Pass/Fail: Pass	Overall Compliance: No
Severity Score: 5			
Codes/Mitigation Info/Possible Solution		Field Measurements/Component Compliance

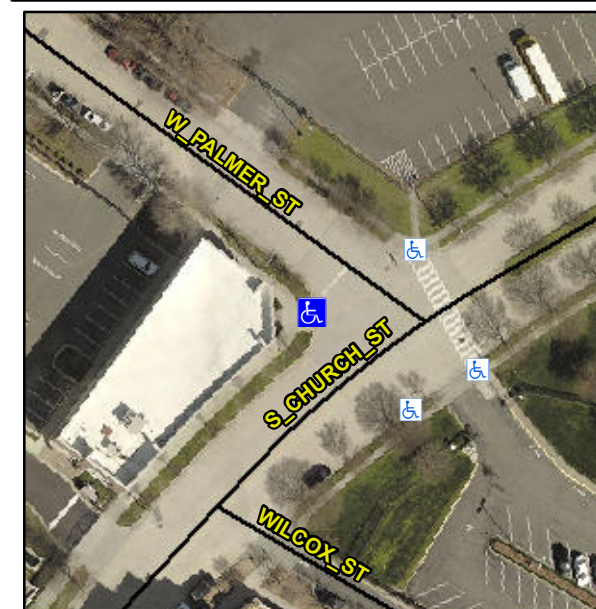
Not Found, R304.5.4

Compliance	Description	Data	Compliance	Description	Data
N/A	Ramp Length (in)	98.0	Yes	Ramp Slope (%)	6.8
Yes	Ramp Width (in)	48.0	Yes	Ramp XSlope (%)	1.2
N/A	Flare Type LT	Sloped	N/A	Flare Type RT	N/A
N/A	Flare Slope LT (%)	9.8	Yes	Flare Slope RT (%)	6.8
N/A	Flare Traversable LT?	Yes	N/A	Flare Traversable RT?	Yes
Yes	Landing Length (in)	48.0	Yes	DWS Provided?	Yes
Yes	Landing Width (in)	48.0	Yes	DWS Contrast?	Yes
Yes	Landing Slope (%)	2.0	Yes	DWS Length (in)	24.0
Yes	Landing X Slope (%)	1.1	Yes	DWS Full Width?	Yes
N/A	Landing Curb? (Y/N)	No	Yes	DWS Offset (in)	1.0
N/A	Shared Landing?	No			
Yes	Gutter Ponding?	No	No	Gutter Slope (%)	7.0
Yes	Gutter Lip Ht (in)	0.0	Yes	Gutter X Slope (%)	0.4
N/A	Painted X Walk1?	No	N/A	Painted X Walk2?	No
	X Walk 1 Direction	To SE		X Walk 2 Direction	To NE
N/A	X Walk 1 Width (in)	N/A	N/A	X Walk 2 Width (in)	N/A
	X Walk 1 Slope (%)	0.5		X Walk 2 Slope (%)	1.7
	X Walk 1 X Slope (%)	0.3		X Walk 2 X Slope (%)	2.2

N/A	Ramp inside XWalk1?	N/A	N/A	Ramp inside XWalk2?	N/A
	Road Slope (%)	0.2	N/A	Clear Space?	Yes
	Road X Slope (%)	1.4	N/A	Clear Space to XWalk (in)	N/A
Yes	Any Obstructions?	No	Yes	Storm Grate/Utility Hazard?	No
	Obstruction Type			Storm Grate/Utility Type	
		N/A			N/A
			Yes	Surface Condition? (G/P)	Good

Remove & Replace Curb Slope and Extend Ramp. Remove & Replace Gutter.
