## **Access Compliance Report Public Rights-of-Way** (Curb Ramps)

Intersection ID: 45492 Main Street: COTTON STAND RD Cross Street: TRIANGLE PARK RD NE Location: **ADA ID: CDCD5761750B Severity Score:** 0 Ramp Type: Combination1Diag Initial Pass/Fail: Fail **Overall Compliance: No**

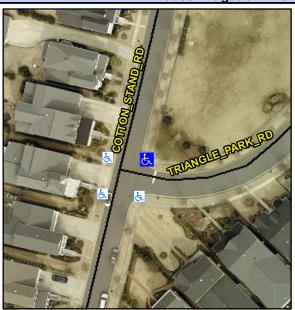
None **COTTON STAND RD** StopSign TRIANGLE PARK RD Possible Solutions: Remove & Replace Curb Ramp With Two New Directional Ramps or Equivalent. Surveyor Notes: RT RP < 5% PROW/ADA Not Found, R304.5.1, R304.2.2, R304.5.3
