# Access Compliance Report

## Public Rights-of-Way

| Intersection ID: 14622 | Main Street: DURHAM_DR | Cross Street: VAIL_AV | Location: S |
| ADA ID: CDE46D059223 | Ramp Type: BlendTrans1 | Initial Pass/Fail: Fail | Overall Compliance: No |

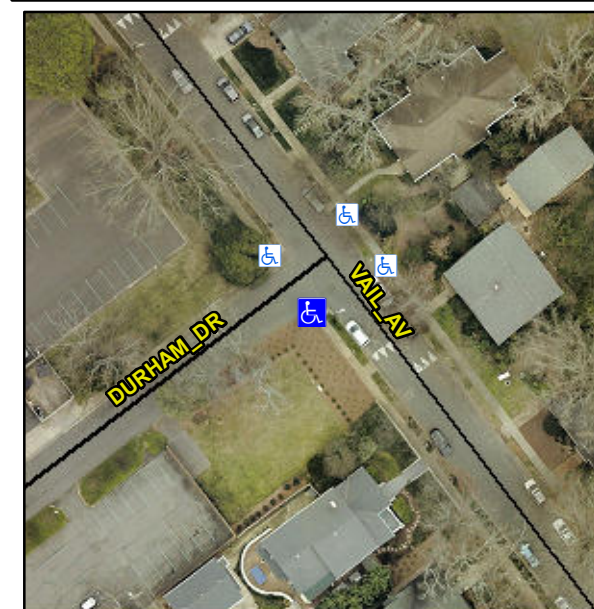
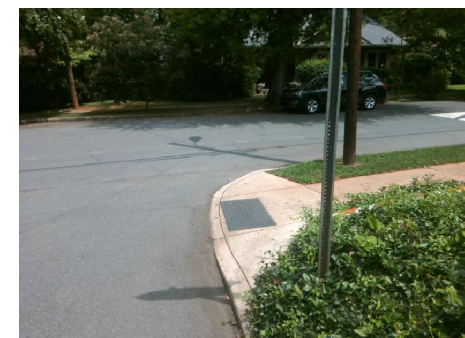
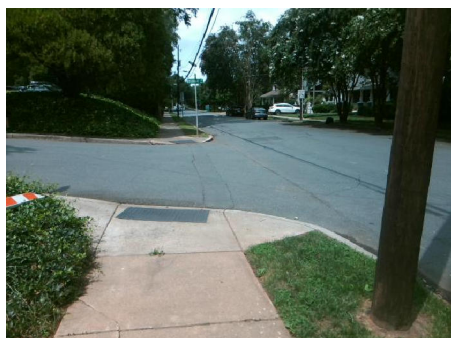
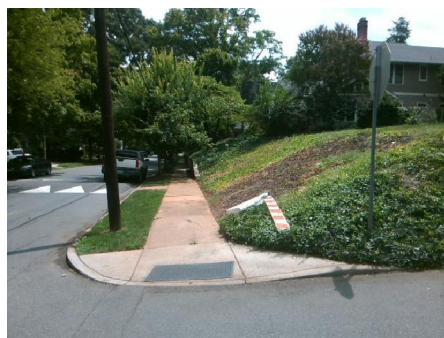
| Severity Score: 25 | | | |

**R304.5.3**

| Compliance | Description | Data | Compliance | Description | Data |
|---|---|---|---|---|---|
| Yes | Ramp Width (in) | 61.0 | No | BlendTrans XSlope (%) | 8.2 |

**Remove & Replace Curb Ramp With Two New Directional Ramps or Equivalent.**

**\$ 3200.00**
