Access Compliance Report

Public Rights-of-Way

(Curb Ramps)

Intersection ID: 9653	Main Street: EDISON_ST	Cross Street: WOODWARD_AV	Location: NE
ADA ID: CDF1F98108D9	Ramp Type: Para	Initial Pass/Fail: Fail	Overall Compliance: No
Severity Score: 1.25			
Codes/Mitigation Info/Possible Solution		Field Measurements/Component Compliance

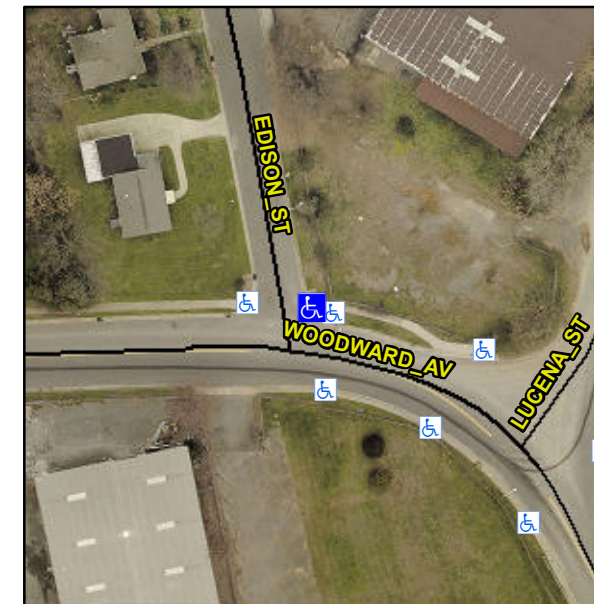
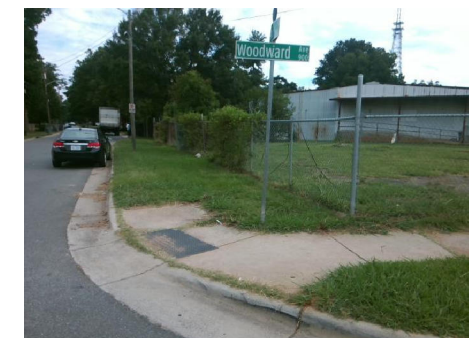
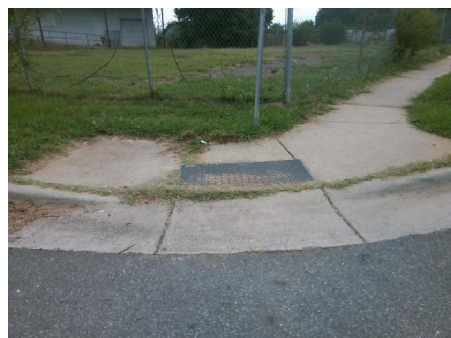
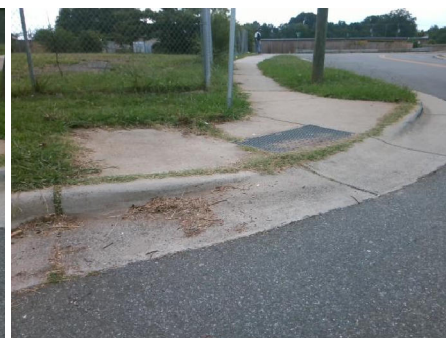
Compliance	Description	Data	Compliance	Description	Data
N/A	Ramp Length LT (in)	63.5	N/A	Ramp Length RT (in)	35.0
Yes	Ramp Width LT (in)	59.0	Yes	Ramp Width RT (in)	62.0
Yes	Ramp Slope LT (%)	7.5	Yes	Ramp Slope RT (%)	7.4
No	Ramp XSlope LT (%)	3.8	No	Ramp XSlope RT (%)	3.3
N/A	Landing Length (in)	N/A	N/A	DWS Provided?	N/A
N/A	Landing Width (in)	N/A	N/A	DWS Contrast?	N/A
N/A	Landing Slope (%)	N/A	N/A	DWS Length (in)	N/A
N/A	Landing X Slope (%)	N/A	N/A	DWS Full Width?	N/A
N/A	Landing Curb? (Y/N)	N/A	N/A	DWS Offset (in)	N/A
N/A	Shared Landing?	N/A			
N/A	Gutter Ponding?	N/A	N/A	Gutter Slope (%)	N/A
N/A	Gutter Lip Ht (in)	N/A	N/A	Gutter X Slope (%)	N/A
N/A	Painted X Walk1?	No	N/A	Painted X Walk2?	N/A
	X Walk 1 Direction	To W		X Walk 2 Direction	N/A
N/A	X Walk 1 Width (in)	N/A	N/A	X Walk 2 Width (in)	N/A
	X Walk 1 Slope (%)	4.4		X Walk 2 Slope (%)	N/A
	X Walk 1 X Slope (%)	1.6		X Walk 2 X Slope (%)	N/A
N/A	Ramp inside XWalk1?	N/A	N/A	Ramp inside XWalk2?	N/A

Road Slope (%)	N/A	N/A	Clear Space?	N/A
	Road X Slope (%)	N/A	N/A	Clear Space to XWalk (in)	N/A
N/A	Any Obstructions?	N/A	N/A	Storm Grate/Utility Hazard?	N/A
	Obstruction Type			Storm Grate/Utility Type	
		N/A			N/A
			Yes	Surface Condition? (G/P)	Good
			N/A	Curb Slope (%)	23.7

Possible Solutions:

Remove & Replace Entire Ramp.

R304.5.3
