# Access Compliance Report

## Public Rights-of-Way

### (Curb Ramps)

Intersection ID: 11227	Main Street: N_GRAHAM_ST	Cross Street: NC_MUSIC_FACTORY_BV	Location: E
ADA ID: CDF3C0E53026	Ramp Type: Perp	Initial Pass/Fail: Fail	Overall Compliance: No
		Severity Score: 10

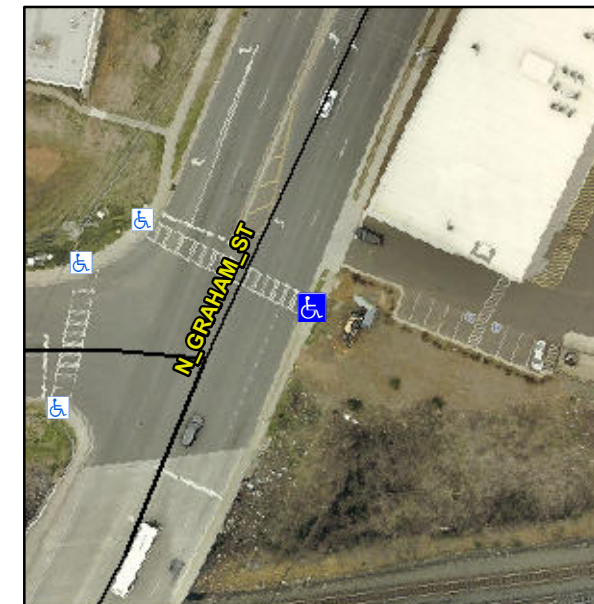
**Not Found, R304.5.1, R304.5.3**

Compliance	Description	Data	Compliance	Description	Data
N/A	Ramp Length (in)	84.0	Yes	Ramp Slope (%)	6.5
No	Ramp Width (in)	47.0	No	Ramp XSlope (%)	4.3
N/A	Flare Type LT	N/A	N/A	Flare Type RT	N/A
N/A	Flare Slope LT (%)	N/A	N/A	Flare Slope RT (%)	N/A
N/A	Flare Traversable LT?	N/A	N/A	Flare Traversable RT?	N/A
N/A	Landing Length (in)	N/A	N/A	DWS Provided?	N/A
N/A	Landing Width (in)	N/A	N/A	DWS Contrast?	N/A
N/A	Landing Slope (%)	N/A	N/A	DWS Length (in)	N/A
N/A	Landing X Slope (%)	N/A	N/A	DWS Full Width?	N/A
N/A	Landing Curb? (Y/N)	N/A	N/A	DWS Offset (in)	N/A
N/A	Shared Landing?	N/A			
N/A	Gutter Ponding?	N/A	N/A	Gutter Slope (%)	N/A
N/A	Gutter Lip Ht (in)	N/A	N/A	Gutter X Slope (%)	N/A
N/A	Painted X Walk1?	Yes	N/A	Painted X Walk2?	N/A
	X Walk 1 Direction	To NW		X Walk 2 Direction	N/A
N/A	X Walk 1 Width (in)	113.0	N/A	X Walk 2 Width (in)	N/A
	X Walk 1 Slope (%)	0.0		X Walk 2 Slope (%)	N/A
	X Walk 1 X Slope (%)	3.8		X Walk 2 X Slope (%)	N/A

N/A	Ramp inside XWalk1?	Yes	N/A	Ramp inside XWalk2?	N/A
	Road Slope (%)	N/A	N/A	Clear Space?	N/A
	Road X Slope (%)	N/A	N/A	Clear Space to XWalk (in)	N/A
N/A	Any Obstructions?	N/A	N/A	Storm Grate/Utility Hazard?	N/A
	Obstruction Type			Storm Grate/Utility Type	
		N/A			N/A
			Yes	Surface Condition? (G/P)	Good

**Remove & Replace Entire Ramp.**

Total Cost: \$ 1850.00
