Access Compliance Report

Public Rights-of-Way

(Curb Ramps)

Intersection ID: 3628	Main Street: DICKSON_LN	Cross Street: MAYCROFT_DR	Location: E
ADA ID: CDFFAA5F8388	Ramp Type: Perp	Initial Pass/Fail: Fail	Overall Compliance: No
Severity Score: 33.75			
Codes/Mitigation Info/Possible Solution		Field Measurements/Component Compliance

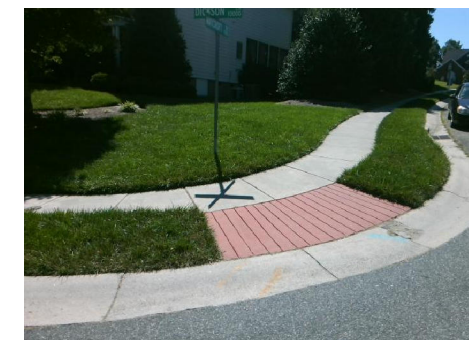
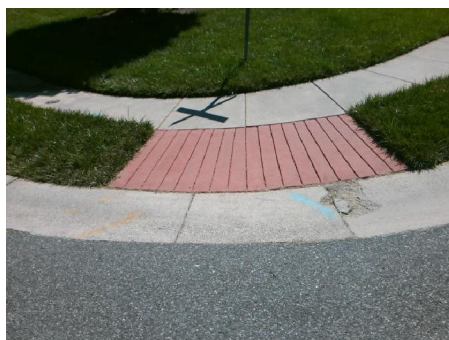
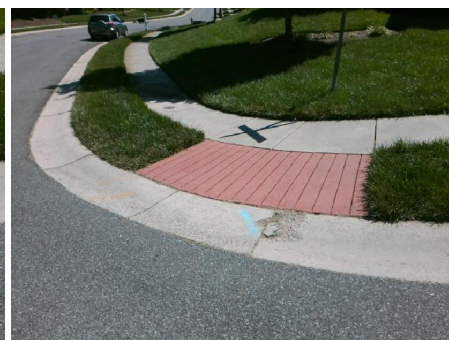
Not Found, R304.5.1, R304.5.3

Compliance	Description	Data	Compliance	Description	Data
N/A	Ramp Length (in)	49.0	Yes	Ramp Slope (%)	7.0
No	Ramp Width (in)	42.0	No	Ramp XSlope (%)	12.7
N/A	Flare Type LT	N/A	N/A	Flare Type RT	N/A
N/A	Flare Slope LT (%)	N/A	N/A	Flare Slope RT (%)	N/A
N/A	Flare Traversable LT?	N/A	N/A	Flare Traversable RT?	N/A
N/A	Landing Length (in)	N/A	N/A	DWS Provided?	N/A
N/A	Landing Width (in)	N/A	N/A	DWS Contrast?	N/A
N/A	Landing Slope (%)	N/A	N/A	DWS Length (in)	N/A
N/A	Landing X Slope (%)	N/A	N/A	DWS Full Width?	N/A
N/A	Landing Curb? (Y/N)	N/A	N/A	DWS Offset (in)	N/A
N/A	Shared Landing?	N/A			
N/A	Gutter Ponding?	N/A	N/A	Gutter Slope (%)	N/A
N/A	Gutter Lip Ht (in)	N/A	N/A	Gutter X Slope (%)	N/A
N/A	Painted X Walk1?	No	N/A	Painted X Walk2?	N/A
	X Walk 1 Direction	To NW		X Walk 2 Direction	N/A
N/A	X Walk 1 Width (in)	N/A	N/A	X Walk 2 Width (in)	N/A
	X Walk 1 Slope (%)	4.3		X Walk 2 Slope (%)	N/A
	X Walk 1 X Slope (%)	7.4		X Walk 2 X Slope (%)	N/A

N/A	Ramp inside XWalk1?	N/A	N/A	Ramp inside XWalk2?	N/A
	Road Slope (%)	N/A	N/A	Clear Space?	N/A
	Road X Slope (%)	N/A	N/A	Clear Space to XWalk (in)	N/A
N/A	Any Obstructions?	N/A	N/A	Storm Grate/Utility Hazard?	N/A
	Obstruction Type			Storm Grate/Utility Type	
		N/A			N/A
		Yes		Surface Condition? (G/P)	Good

Remove & Replace Entire Ramp.
