Access Compliance Report

Public Rights-of-Way

(Curb Ramps)

Intersection ID: 29147	Main Street: BALSAM_TREE_DR	Cross Street: WALLACE_RIDGE_DR	Location: SE
ADA ID: CE0A39492DF0	Ramp Type: BlendTrans1	Initial Pass/Fail: Fail	Overall Compliance: No
		Severity Score: 25

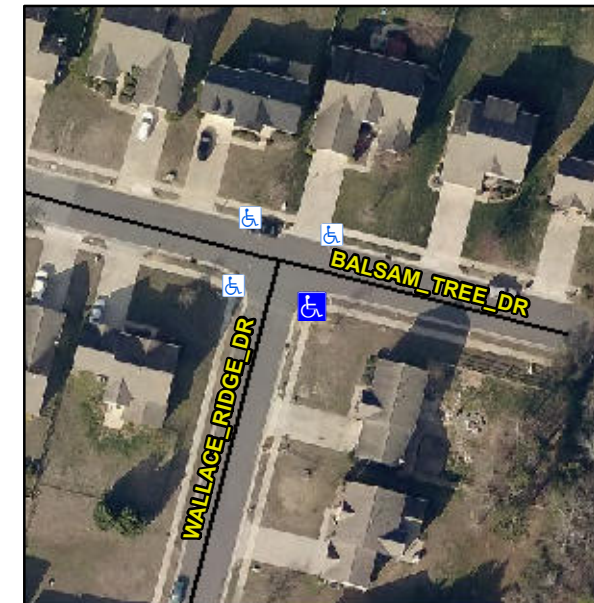
Not Found, R304.5.3

Compliance	Description	Data	Compliance	Description	Data
N/A	Ramp Length (in)	48.0	Yes	BlendTrans Slope (%)	3.8
Yes	Ramp Width (in)	144.0	No	BlendTrans XSlope (%)	8.3
N/A	Flare Type LT	N/A	N/A	Flare Type RT	N/A
N/A	Flare Slope LT (%)	N/A	N/A	Flare Slope RT (%)	N/A
N/A	Flare Traversable LT?	N/A	N/A	Flare Traversable RT?	N/A
N/A	Landing Length (in)	N/A	N/A	DWS Provided?	N/A
N/A	Landing Width (in)	N/A	N/A	DWS Contrast?	N/A
N/A	Landing Slope (%)	N/A	N/A	DWS Length (in)	N/A
N/A	Landing X Slope (%)	N/A	N/A	DWS Full Width?	N/A
N/A	Landing Curb? (Y/N)	N/A	N/A	DWS Offset (in)	N/A
N/A	Shared Landing?	N/A			
N/A	Gutter Ponding?	N/A	N/A	Gutter Slope (%)	N/A
N/A	Gutter Lip Ht (in)	N/A	N/A	Gutter X Slope (%)	N/A
N/A	Painted X Walk1?	No	N/A	Painted X Walk2?	No
	X Walk 1 Direction	To N		X Walk 2 Direction	To NW
	X Walk 1 Width (in)	N/A		X Walk 2 Width (in)	N/A
	X Walk 1 Slope (%)	1.4		X Walk 2 Slope (%)	6.9
	X Walk 1 X Slope (%)	8.5		X Walk 2 X Slope (%)	0.3

N/A	Ramp inside XWalk1?	N/A	N/A	Ramp inside XWalk2?	N/A
	Road Slope (%)	4.5		Clear Space?	N/A
	Road X Slope (%)	5.6	N/A	Clear Space to XWalk (in)	N/A
N/A	Any Obstructions?	N/A	N/A	Storm Grate/Utility Hazard?	N/A
	Obstruction Type			Storm Grate/Utility Type	
		N/A			N/A
			Yes	Surface Condition? (G/P)	Good
			No	Curb Slope (%)	7.2

Remove & Replace Curb Ramp With Two New Directional Ramps or Equivalent.
